Inspection Report

Property Address:
1000 Sample Drive
Kansas City MO 64116

Gordon & Associates

Date: 4/20/2019	Time:	Report ID: 219778
Property: 1000 Sample Drive Kansas City MO 64116	Customer: Jane Doe	Real Estate Professional:

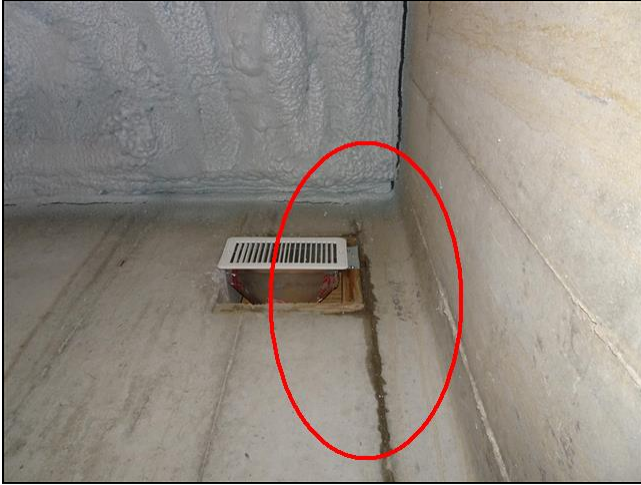
A. (Picture 1)

- A.
- Foundation recommendation; repair as necessary to stop all water intrusion:
1. Below the front entry door (Picture 1).
 2. Below the overhead garage door opening (Picture 2).

- Foundation recommendation; repair as necessary to stop all water intrusion:
 1. Below the front entry door (Picture 1).
 2. Below the overhead garage door opening (Picture 2).

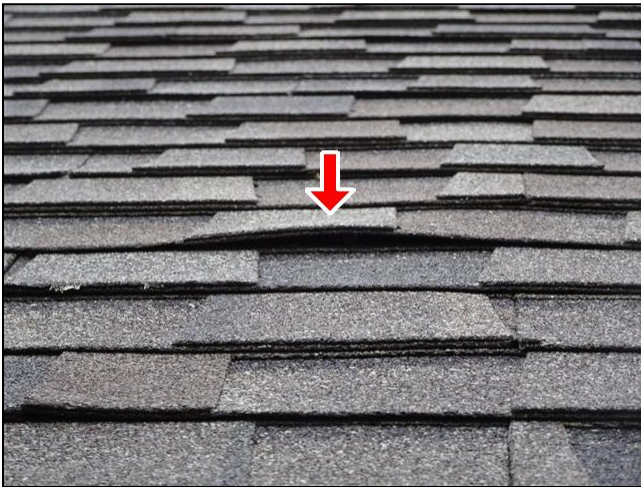
D. (Picture 1)

- D.
- Roof covering deficiencies:
1. Underdriven nails (Picture 1).
 2. Incorrect nail placement (Picture 2).
 3. Undersized flashing; soffit connections (Picture 3).
 4. Unsealed flashing connections (Picture 4-5).
 5. Unsecured roofing (Picture 6).
 6. Multiple nail heads are not sealed (Picture 7).

- Roof covering deficiencies:
 1. Underdriven nails (Picture 1).
 2. Incorrect nail placement (Picture 2).
 3. Undersized flashing; soffit connections (Picture 3).
 4. Unsealed flashing connections (Picture 4-5).
 5. Unsecured roofing (Picture 6).
 6. Multiple nail heads are not sealed (Picture 7).

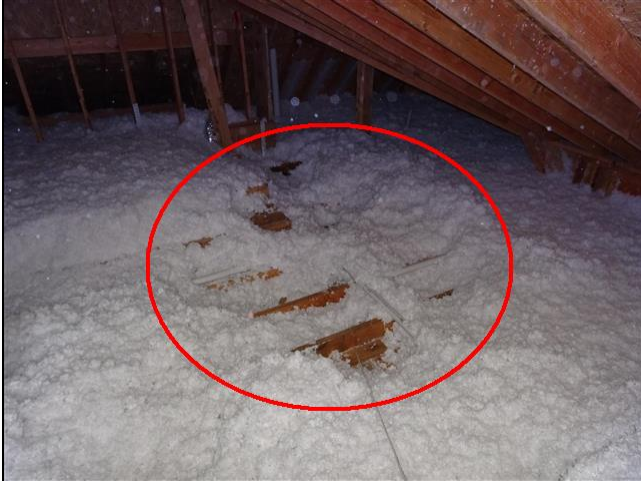
E. (Picture 1)

- Roof Structure & Attic recommendations:
 1. Install additional insulation. Northern White insulation requires 14.3" in depth to reach an R value of 38.
 - A) The depth of insulation is less than 6" in multiple areas; disturbed by contractors (Picture 1).
 - B) In addition; undisturbed depths are well below an R-38 rating (Picture 2-3).
 2. Air seal all applicable ceiling and top wall plate penetrations (Picture 4).

- Roof Structure & Attic recommendations:
 1. Install additional insulation. Northern White insulation requires 14.3" in depth to reach an R value of 38.
 - A) The depth of insulation is less than 6" in multiple areas; disturbed by contractors (Picture 1).
 - B) In addition; undisturbed depths are well below an R-38 rating (Picture 2-3).
 2. Air seal all applicable ceiling and top wall plate penetrations (Picture 4).
 3. Structural engineer review of framing:
 - A) Multiple 2x6 rafters are over spanned (Picture 5).
 - B) Purlins are not supported; front side (Picture 6-7).
 4. Ventilation:
 - A) Increase exhaust vent sheathing cutouts to match the vent NFA (Picture 8).
 - B) Install additional intake vents to balance the system (approximately 18 additional 8x16 soffit vents).
Current venting calculation; intake 728" NFA, exhaust 1,769" NFA.

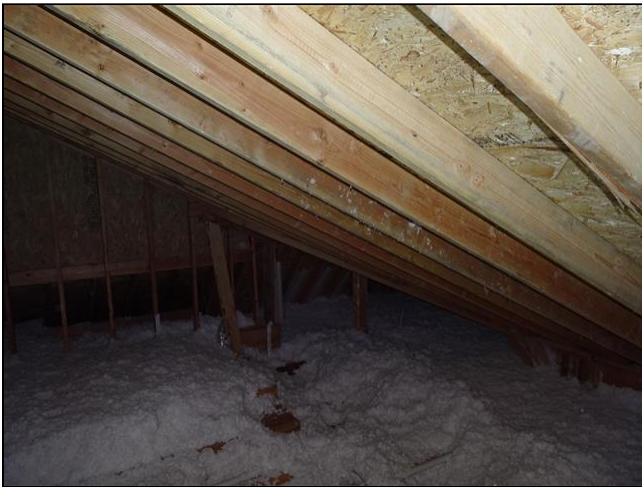
E. (Picture 5)

- 3. Structural engineer review of framing:
 - A) Multiple 2x6 rafters are over spanned (Picture 5).
 - B) Purlins are not supported; front side (Picture 6-7).
- 4. Ventilation:
 - A) Increase exhaust vent sheathing cutouts to match the vent NFA (Picture 8).
 - B) Install additional intake vents to balance the system (approximately 18 additional 8x16 soffit vents). Current venting calculation; intake 728" NFA, exhaust 1,769" NFA.

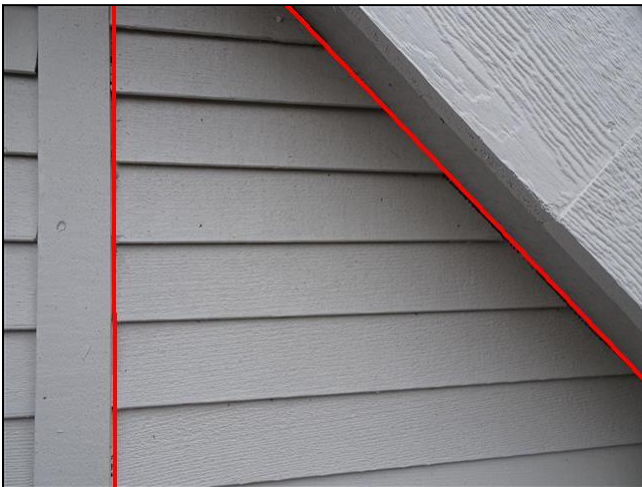
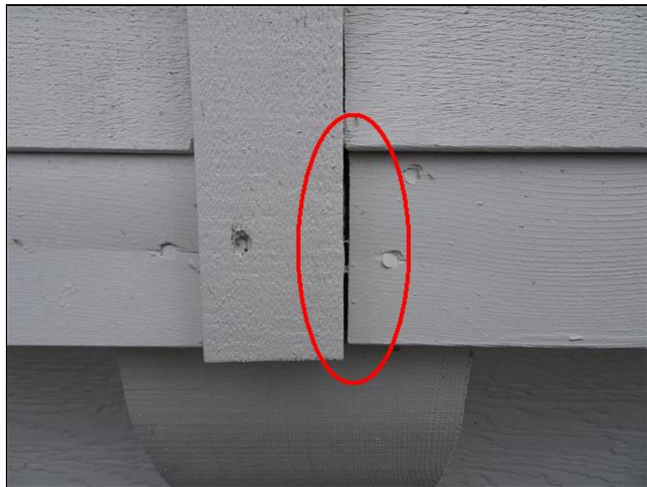
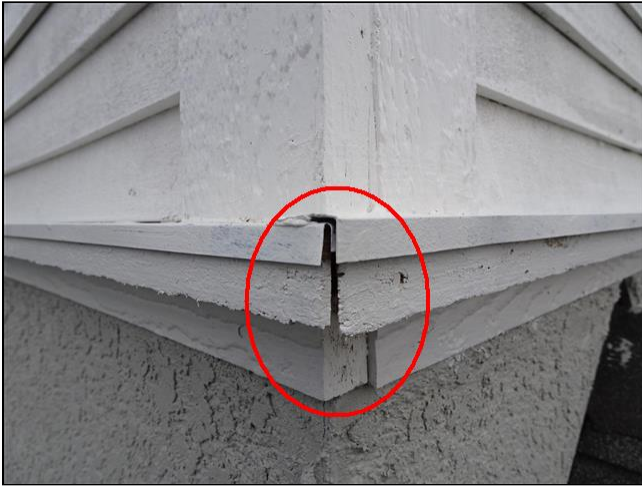
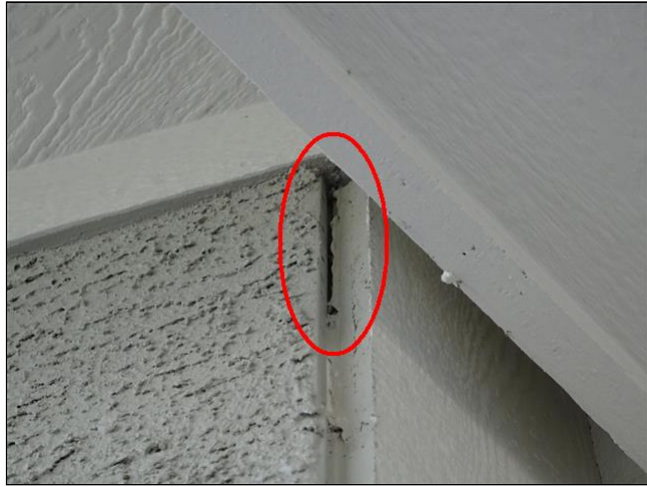
- Exterior deficiencies:
 1. Incomplete caulking (Picture 1-4).
 2. Incomplete paint coverage (Picture 5-6).

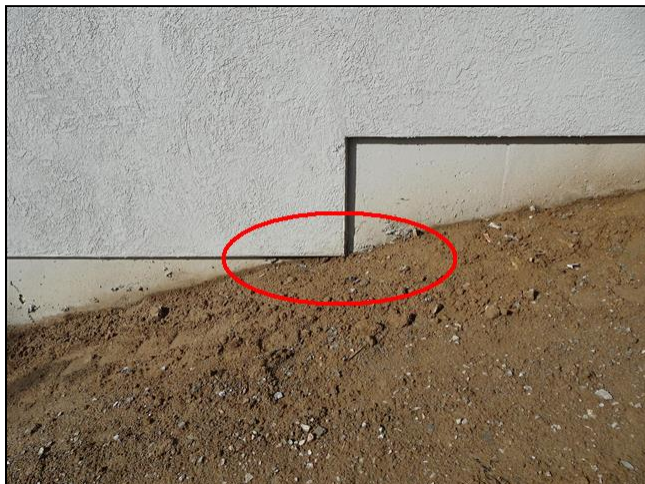
F. (Picture 7)

- Exterior deficiencies continued:
 1. Stucco terminates with soil (Picture 7).
 2. Bent horizontal flashing (Picture 8).
 3. Deck ledger board:
 - A) Incomplete flashing/sealing (Picture 9-10).
 - B) Existing flashing does not overlap the ledger board (Picture 11).

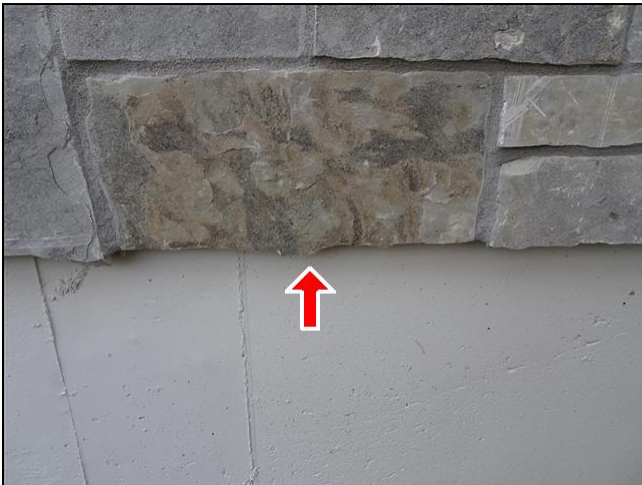
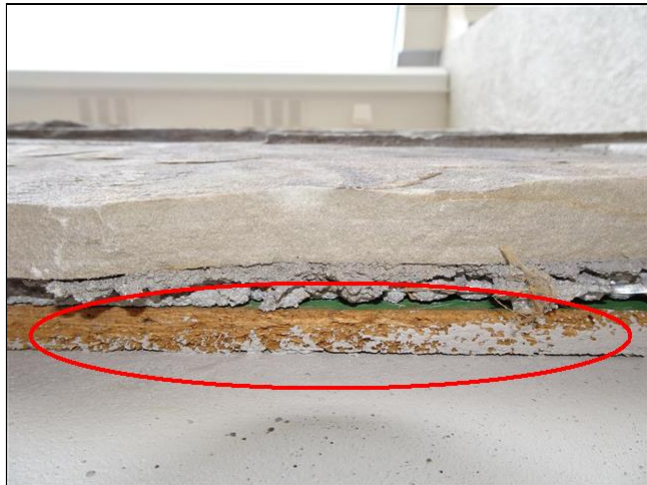
- Exterior deficiencies continued:
 1. Weep screed is not installed at the base of the stone veneer substrate (Picture 13-14).
 2. A seal is not installed between the siding and front porch stone (Picture 15).

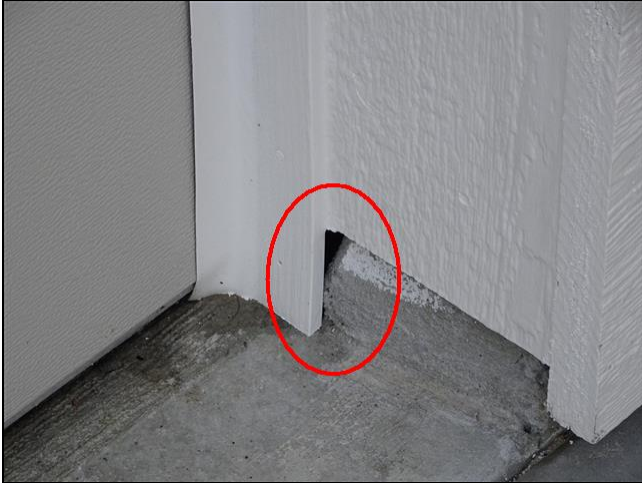
H. (Picture 1)

1. Inadequate door seals:
 - A) Overhead garage door openings (Picture 1).
 - B) Basement level, east entry doors; visible daylight; (Picture 2).
2. Elevator folding door; conflicts with the door opening trim (during elevator operation).
3. Doors conflict with the door casings:
 - A) Main level elevator door.
 - B) North lower level storage room, entry door.
4. Office sliding glass door; difficult to lock/unlock.
5. Lower level, east entry door; difficult to open/close.

- Door deficiencies:
 1. Inadequate door seals:
 - A) Overhead garage door openings (Picture 1).
 - B) Basement level, east entry doors; visible daylight; (Picture 2).
 2. Elevator folding door; conflicts with the door opening trim (during elevator operation).
 3. Doors conflict with the door casings:
 - A) Main level elevator door.
 - B) North lower level storage room, entry door.
 4. Office sliding glass door; difficult to lock/unlock.
 5. Lower level, east entry door; difficult to open/close.

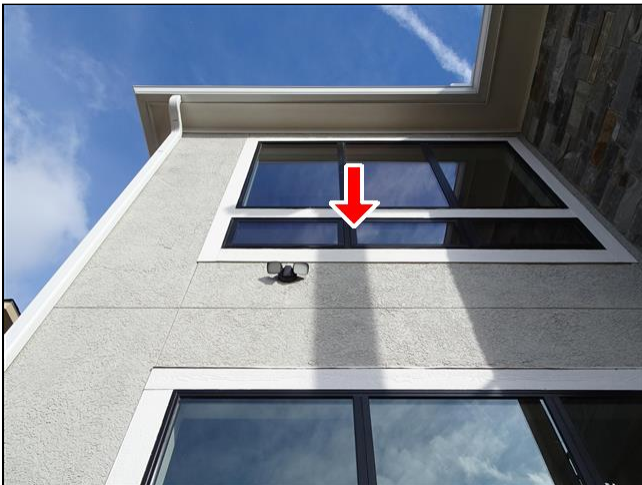
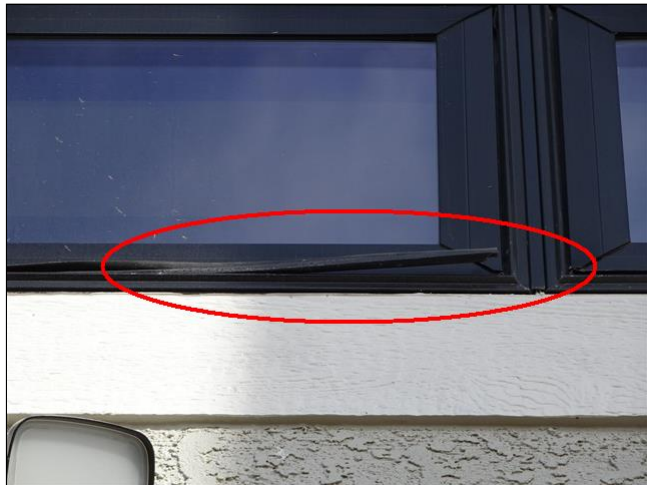
- I.
- Window deficiencies:
 1. East master bedroom window; weather stripping is disconnected (Picture 1-2).
 2. West dining room window; shipping packing has not been removed (Picture 3).

- Window deficiencies:
 1. East master bedroom window; weather stripping is disconnected (Picture 1-2).
 2. West dining room window; shipping packing has not been removed (Picture 3).

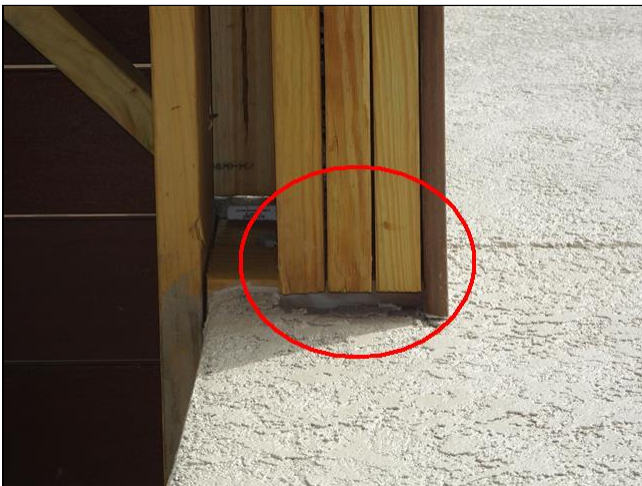
K. (Picture 1)

- Deck deficiencies:
 1. Incomplete joist hanger installation (Picture 1).
 2. Incomplete joist hanger nail installation (Picture 2).
 3. Multiple joist hanger nails are not labeled as 10d nails.
 4. Support posts terminate with soil (Picture 3).

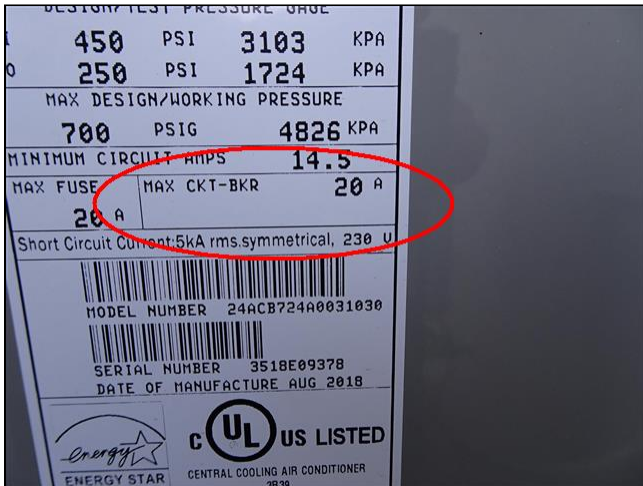
A. (Picture 1)

- Service Entrance and Panels:
 1. AC unit circuit breakers are oversized, (Picture 1) 20 Amps max, (Picture 2) 30s are currently installed.
 2. Exterior conduit is disconnected (Picture 3-4).
 3. Interior; center panels:
 - A) Wire grommet clamp is not secured (Picture 6).
 - B) Supply wire clamps are disconnected (Picture 7).

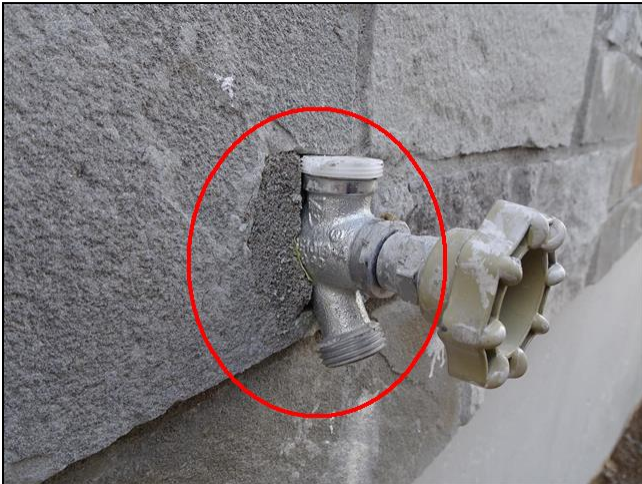
A. (Picture 1)

- A.**
1. South water spigot (Picture 1).
 A) Improperly encased in masonry.
 B) Missing anti-siphon cap.
 2. Lower level bathroom tub faucet handle/fixture connection is loose.

1. South water spigot (Picture 1).
 - A) Improperly encased in masonry.
 - B) Missing anti-siphon cap.
2. Lower level bathroom tub faucet handle/fixture connection is loose.

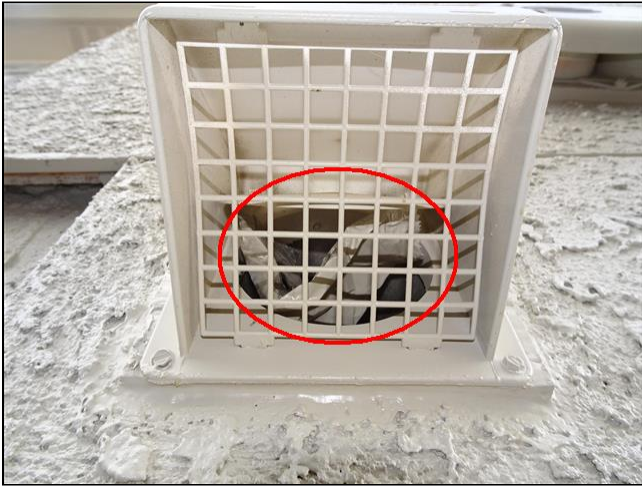
B. (Picture 1)

1. South vent opening is obstructed (Picture 1).
2. North vent damper is stuck in the open position (Picture 2).

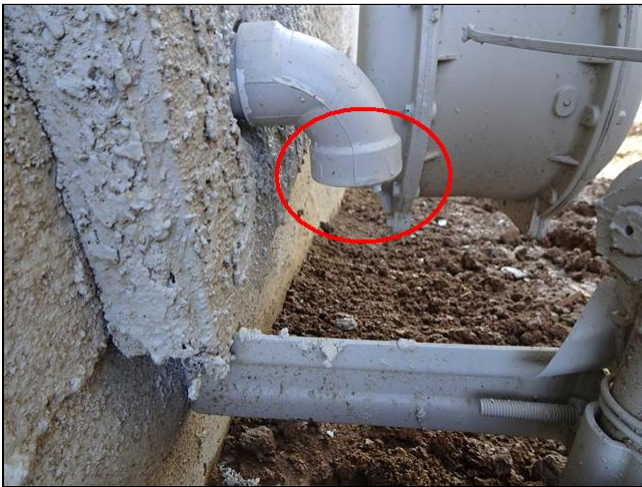
D. (Picture 1)

- Sump pump recommendations:
 1. Extend discharge pipe a minimum of 6 feet from the foundation (Picture 1).
 2. Seal exterior wall penetration (Picture 2).
 3. Install a backup system.
