Inspection Report

Property Address:
9000 Sample Drive
Overland Park KS 66213

Gordon & Associates

Date: 9/4/2019	Time:	Report ID: 219777
Property: 9000 Sample Drive Overland Park KS 66213	Customer: John Doe	Real Estate Professional:

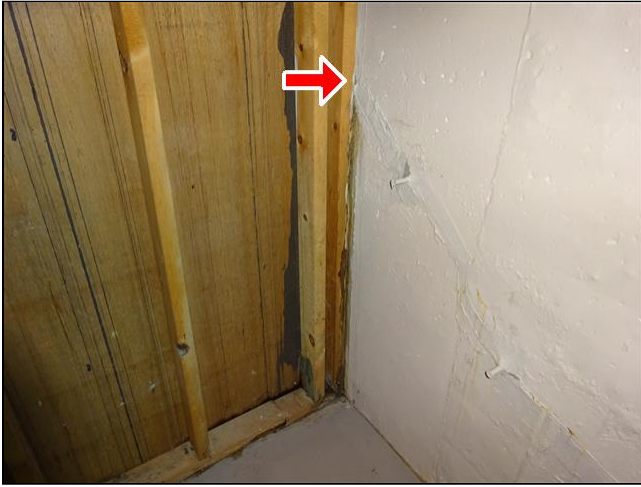
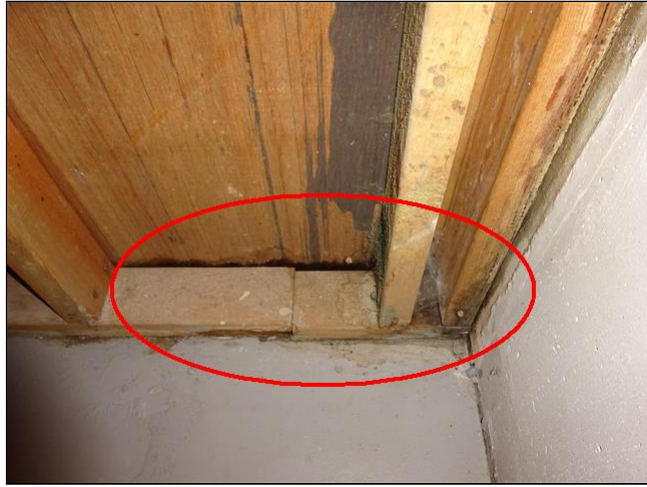
- Foundation recommendations:
 1. Re-seal crack at east wall as necessary to stop water intrusion; wet at time of inspection (Picture 1-2).
 2. Seal/waterproof front porch slab foundation connection (Picture 3).
 3. Seal/waterproof water service line wall penetration (Picture 4).
 4. Improve exterior grading and drainage; see below.

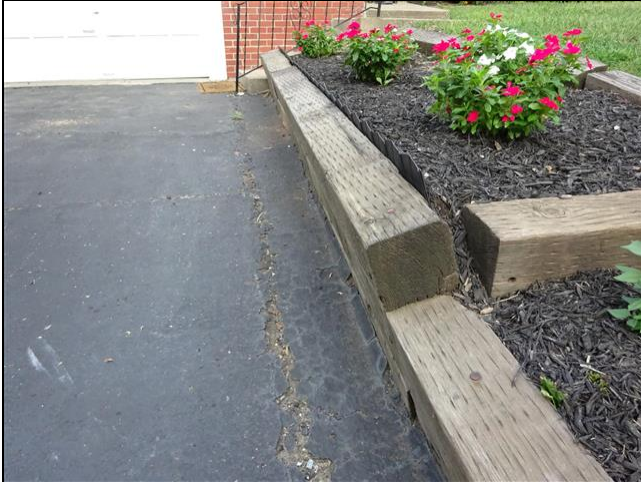
C. (Picture 1)

- Grading & Drainage recommendations:
 1. Final grading around the foundation should provide a minimum of 6" of slope in the first 6' directly away from the foundation while maintaining 6" of clearance to the siding. The grade should provide for an easy flow of surface water away from the foundation and off the property.
 2. The final grade within 3' of the foundation walls should be covered with EPDM or another impervious material to stop water penetration and direct water away from the foundation.
 3. Retaining walls:
 - A) Driveway; total replacement due to lateral settlement (Picture 1).
 - B) West side; total replacement due to location and condition (Picture 2). Install new wall a minimum of 6" to the north.

- Grading & Drainage recommendations:
 1. Final grading around the foundation should provide a minimum of 6" of slope in the first 6' directly away from the foundation while maintaining 6" of clearance to the siding. The grade should provide for an easy flow of surface water away from the foundation and off the property.
 2. The final grade within 3' of the foundation walls should be covered with EPDM or another impervious material to stop water penetration and direct water away from the foundation.
 3. Retaining walls:
 - A) Driveway; total replacement due to lateral settlement (Picture 1).

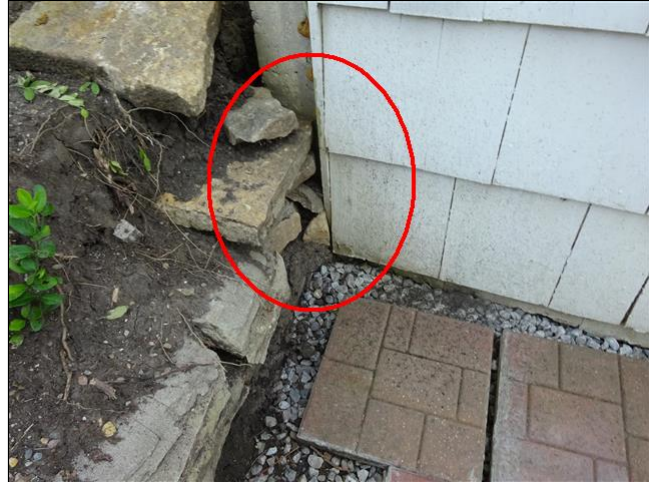
C. (Picture 2)

B) West side; total replacement due to location and condition (Picture 2). Install new wall a minimum of 6" to the north.

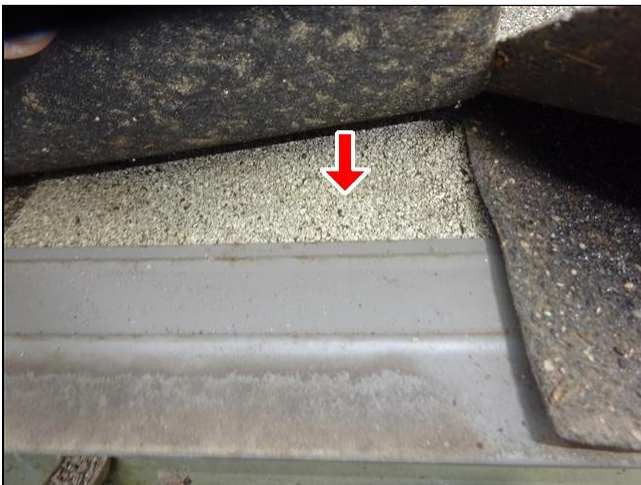
D. (Picture 1)

- Roof covering; total replacement is recommended. Defects not limited to:
 1. Multiple layers of roofing (Picture 1).
 2. Wind and hail damage (Picture 2-3).
 3. Loose nails, nail erosion (Picture 4).

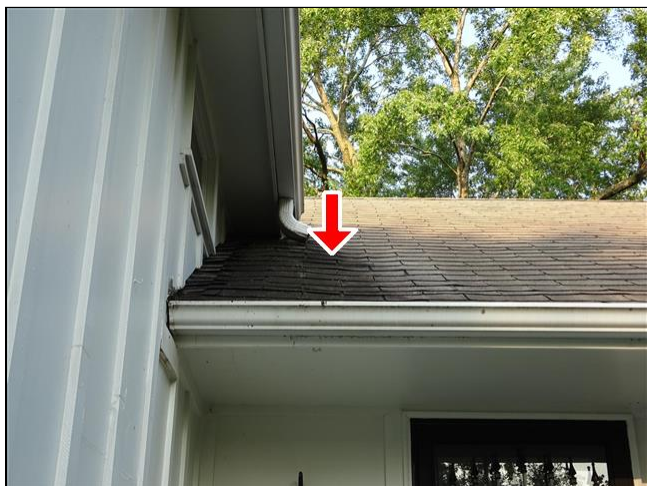
E. (Picture 1)

- Roof structure & attic recommendations:
 1. Replace all water damaged sheathing at time of roof replacement (Picture 1).
 2. Bird nest removal (Picture 2).
 3. Re-insulate the entire attic (Picture 3).
 4. Install additional ventilation at time of roof replacement.

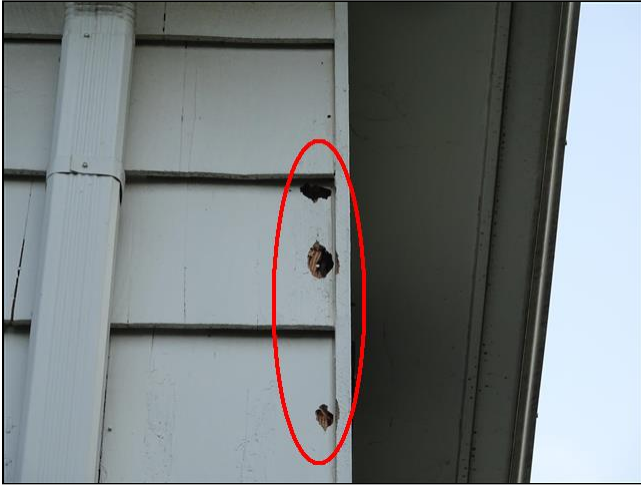
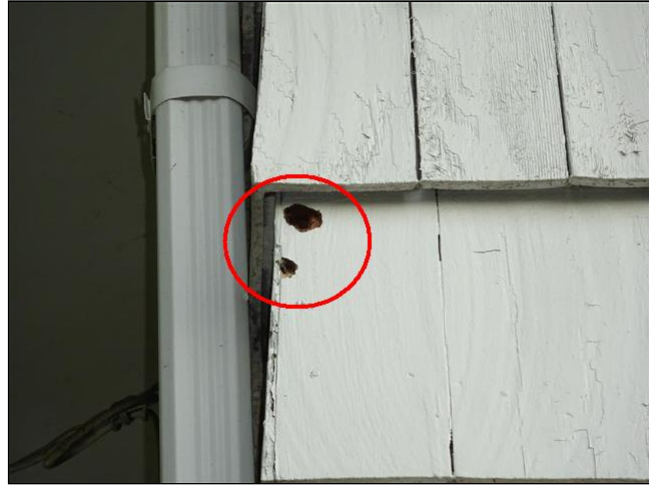
- Exterior deficiencies:
 1. Woodpecker damage (Picture 1-2).
 2. Wood rot damage (Picture 3).
 3. Inadequate wood rot repair (Picture 4).

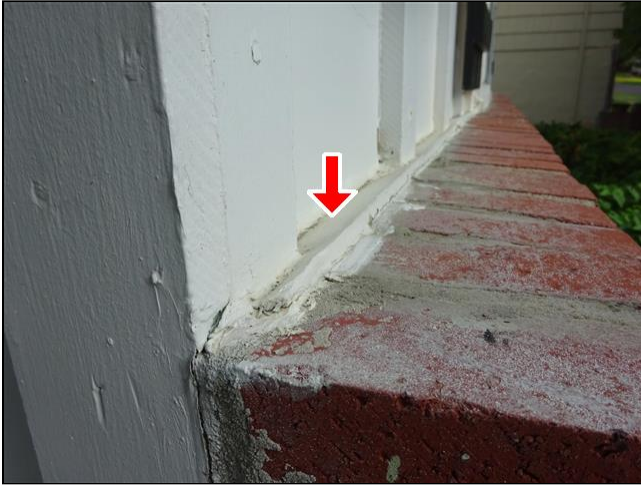
F. (Picture 5)

- Exterior deficiencies continued:
 1. Back-pitched brick flashing (Picture 5).
 2. Brickwork is not adequately supported due to lateral foundation settlement (Picture 6).
 3. Peeling paint (Picture 7).

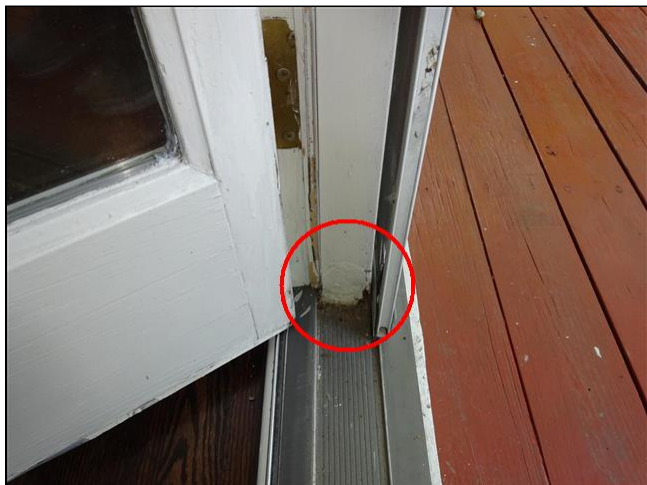
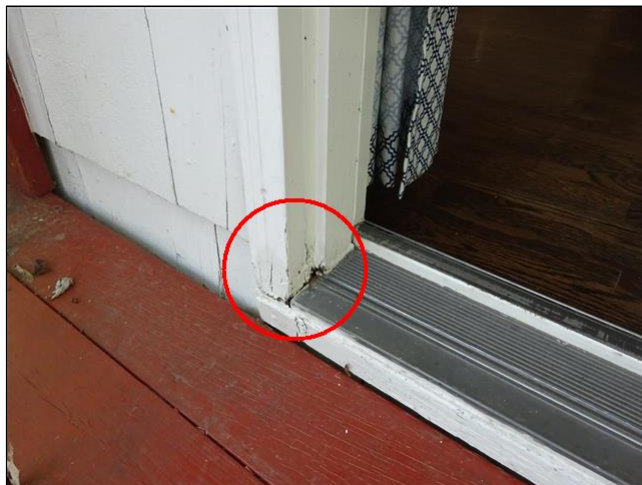
- Door deficiencies:
 1. West deck level entry door; wood rot damage (Picture 1-2).
 2. Doors do not properly latch closed:
 - A) Master bathroom entry door.
 - B) Second level hall closet door.
 3. Master bedroom closet doors; lower door guides are not installed.
 4. SW bedroom entry door hinges: loose.

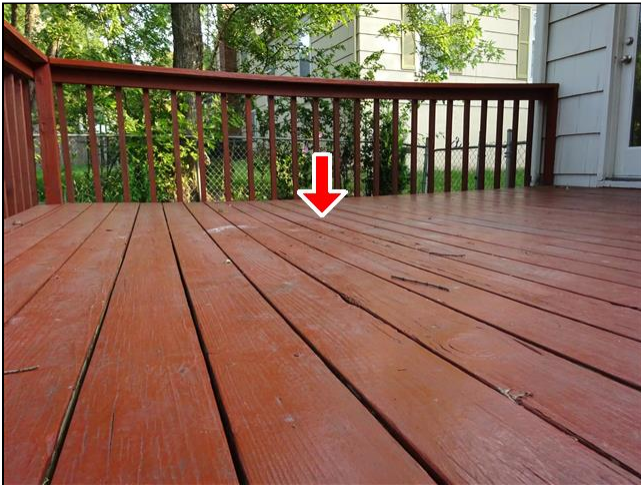
K. (Picture 1)

- Deck deficiencies:
 1. Support post settlement (Picture 1).
 2. Undersized joist hangers (Picture 2).
 3. Main beams are not bearing directly onto the support posts (Picture 3).
 4. Damaged lumber (Picture 4).
 5. Deck ledger board connection is not lag bolted (Picture 5).

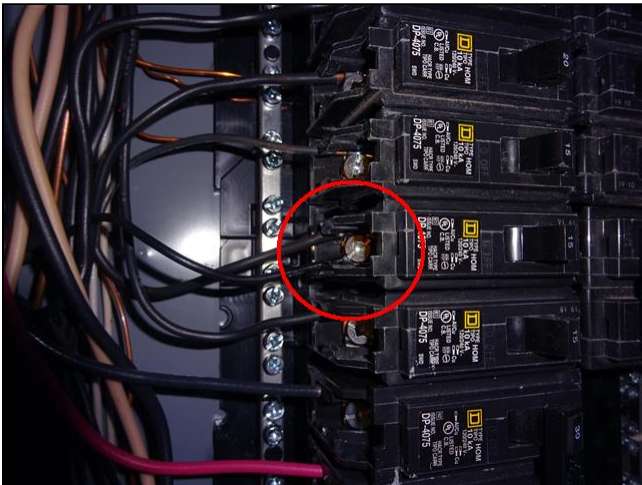
A. (Picture 1)

- A.
- Service Panel deficiencies:
 1. Double tapped circuit breaker (Picture 1).
 2. Existing ground connection is severely corroded (Picture 2).
 3. Circuit breakers are not labeled.

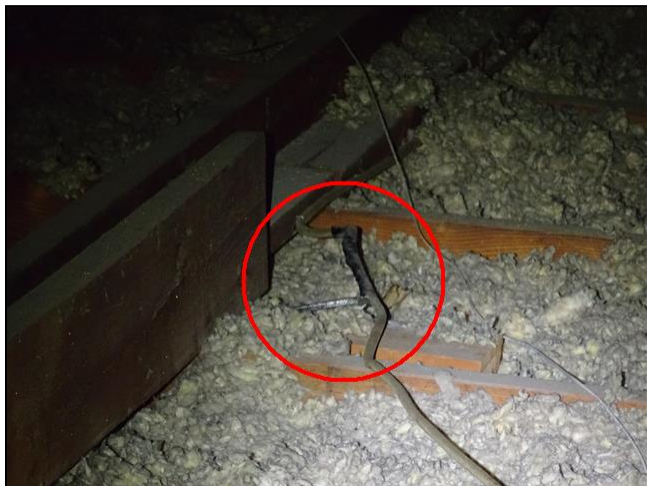
B. (Picture 1)

- Branch Circuit deficiencies:
 1. Attic; multiple wire splices are not installed in junction boxes (Picture 1).
 2. Front exterior receptacle; not protected by a GFCI.
 3. West living room receptacles below bar top (x2); hot and neutral wires are reversed.
 4. Kitchen waste disposal receptacle backer box; disconnected from the wall.
 5. Existing smoke detector is more than 10 years old (replace).

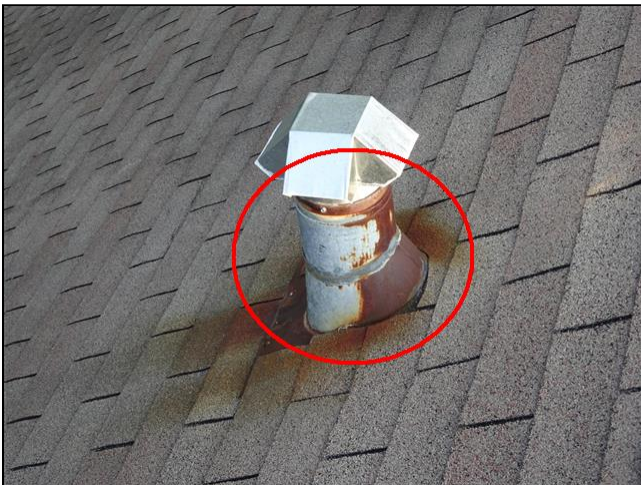
A. (Picture 1)

- Heating system recommendations:
 1. Total flue pipe replacement due to rust damage:
 - A) Exterior (Picture 1).
 - B) Attic (Picture 2).
 - C) Basement (Picture 3).
 2. Repair; additional defects not limited to:
 - A) The furnace is inoperable (burners did not light after 3 cycles).
 - B) Flue pipe is not properly connected to the furnace (Picture 4).
 3. Replace the humidifier.
 4. Clean and service the system.

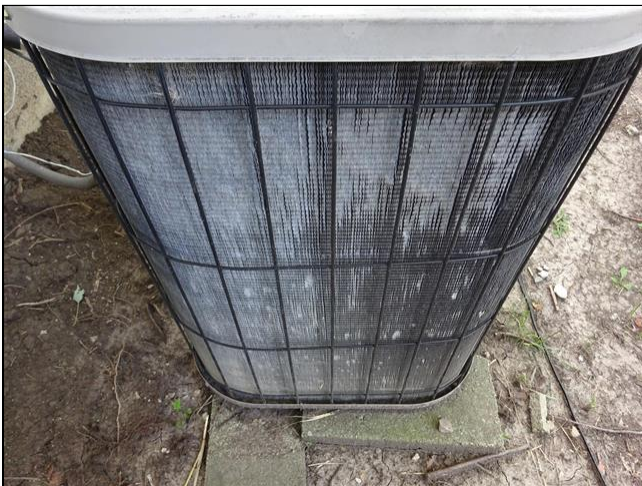
B. (Picture 1)

- B.**
- Cooling system recommendations:
 1. Repair; bent coil fins (Picture 1).
 2. Install service cover screws (Picture 2).
 3. Properly insulate the low pressure line (Picture 3).
 4. Repair:
 - A) Return air ductwork is disconnected from the furnace cabinet (Picture 4).
 - B) Disconnected ductwork; basement ceiling (Picture 5).
 5. Replace filter (currently pulled up against the blower intake).
 6. Clean and service system.
 7. Budget for total replacement due to age.

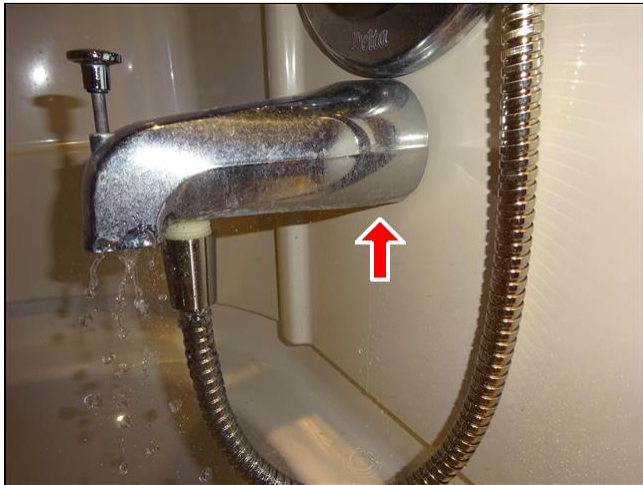
A. (Picture 1)

1. Hall bathroom tub spout connection; leaking (Picture 1).
2. Wet bar sink faucet:
 - A) Cold side leaks during operation (Picture 2).
 - B) Hot side is stuck closed.

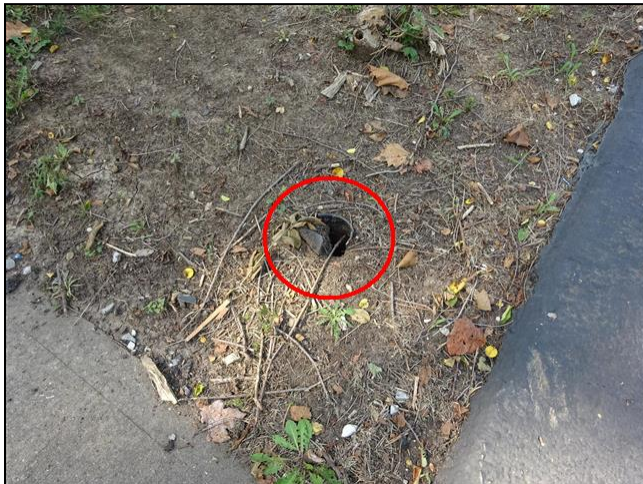
B. (Picture 1)

1. SE exterior; main clean-out outlet is open/damaged (Picture 1).
2. Bathroom sink drains; improper installation (Picture 2-3).
3. Second level hall bathroom tub drain; improper installation (Picture 4).
4. Cast iron drain pipes are in poor condition:
 - A) Main vent pipe is split/cracked inside the hall bathroom wall (Picture 5).

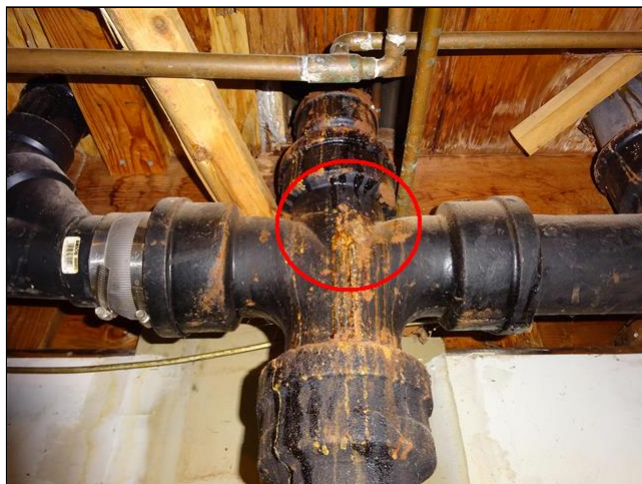
B. (Picture 6)

B) Rust damaged/leaking fittings; garage (Picture 6).

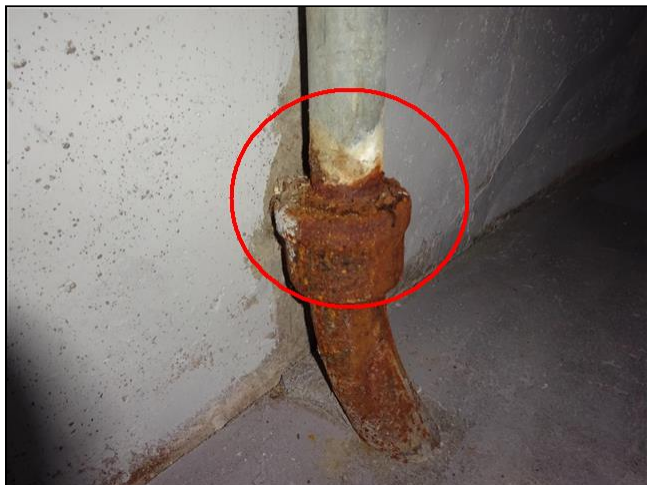
B. (Picture 7)

C) Rust damage; basement level (Picture 7).

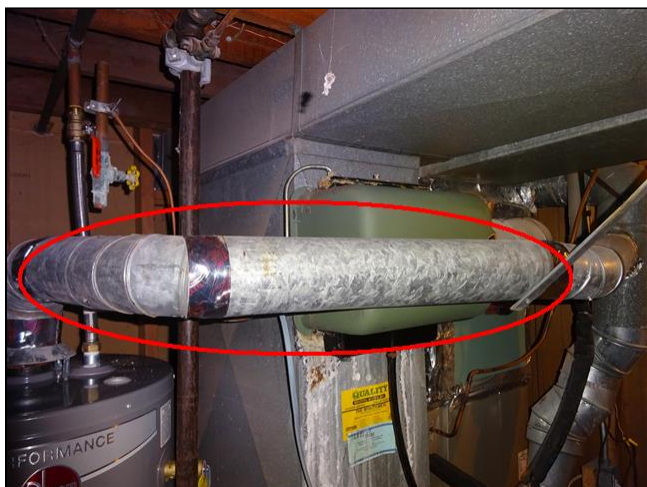
C. (Picture 1)

- Water heater:
 1. The appliance is not in service (no hot water).
 2. Flue pipe is improperly installed; back-pitched (Picture 1).
 3. An expansion tank is not installed on the system.

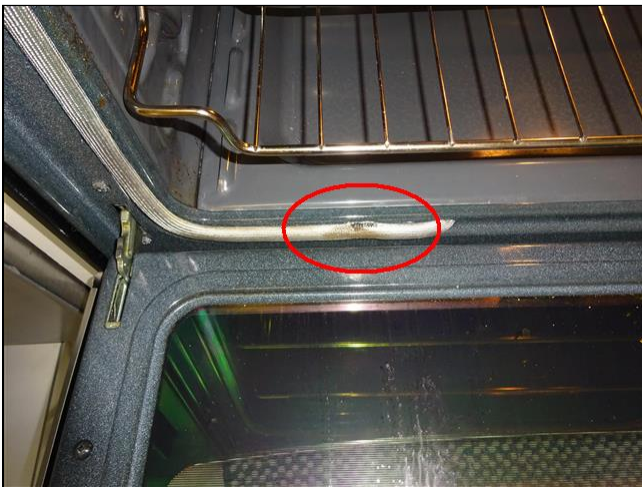
D. (Picture 1)

- Oven/range:
 1. Oven door seal is damaged (Picture 1).
 2. An anti-tip bracket is not installed. This is a safety device that prevents the appliance from tipping forward.
