## Inspection Report

**Property Address:**  
1000 Center Street  
Sample KS

<b>Date:</b> 6/25/2021	<b>Time:</b>	<b>Report ID:</b> 221789
<b>Property:</b> 1000 Center Street Sample KS	<b>Customer:</b>	<b>Real Estate Professional:</b>

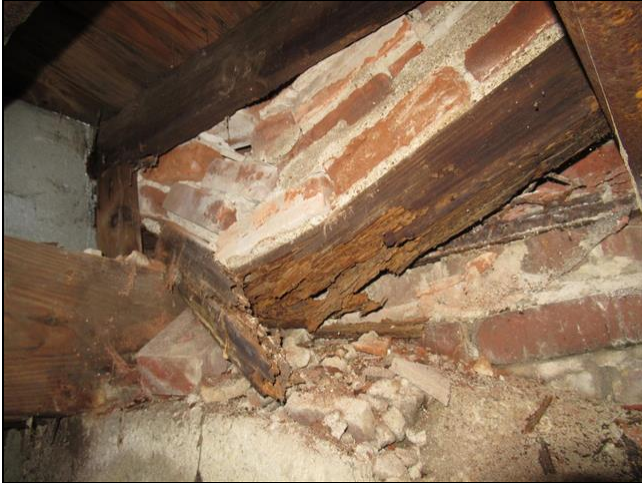
A. (Picture 1)

- Foundation deficiencies:
  1. Sections of brick walls have collapsed into the crawlspace (Picture 1).
  2. Unsupported/bridged brickwork (Picture 2).
  3. Vertical wall settlement in excess of one inch:
    - A) SE corner 1.25".
    - B) SW corner 1.5".
    - C) NW corner 1.75".
    - D) NE corner 1.25".

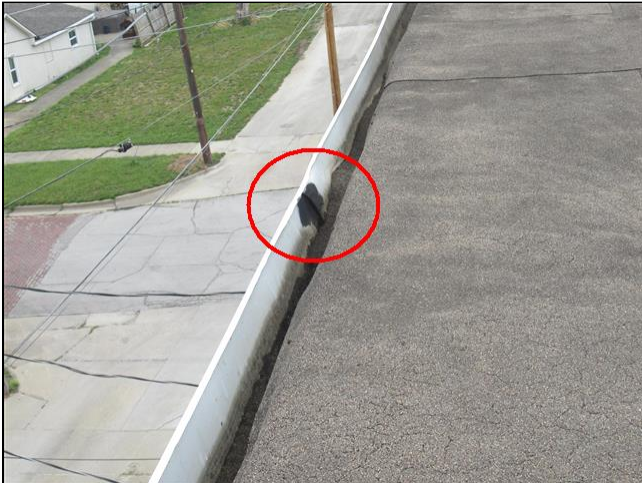
B. (Picture 1)

- Grading & drainage deficiencies:
  1. Leaking guttering system (Picture 1).
  2. Negative soil grading.

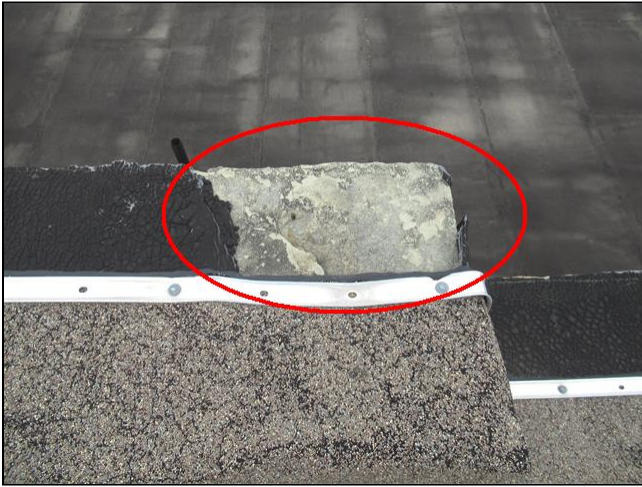
C. (Picture 1)

1. Roofing system deficiencies:
  - A) Incomplete roofing (Picture 1).
  - B) Open seams (Picture 2-4).
  - C) Overlaid; multiple layers of roofing (Picture 5).
  - D) Craze/cracking (Picture 6).
  - E) Leaking (interior water stains).

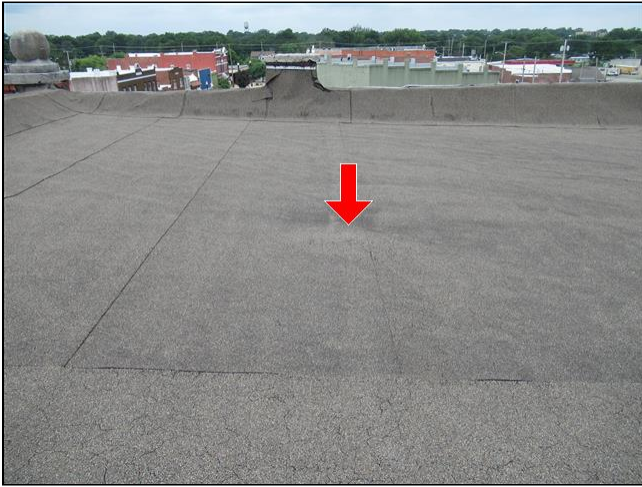
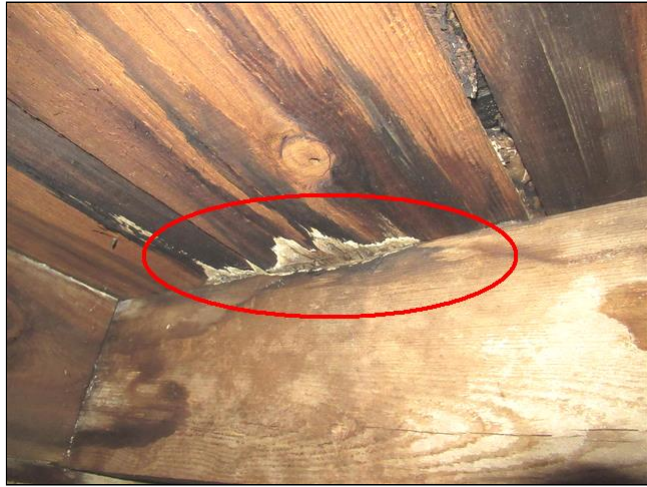
- 1. Roof structure & attic deficiencies:
  - A) Water damage (Picture 1-2).

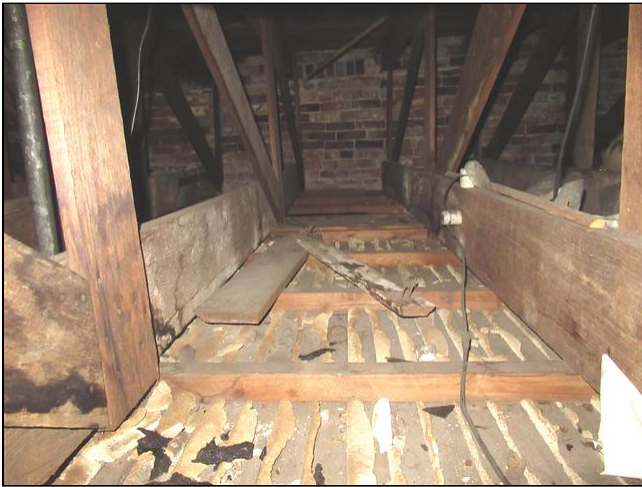
D. (Picture 3)

B) The attic is un-insulated and un-ventilated (Picture 3).

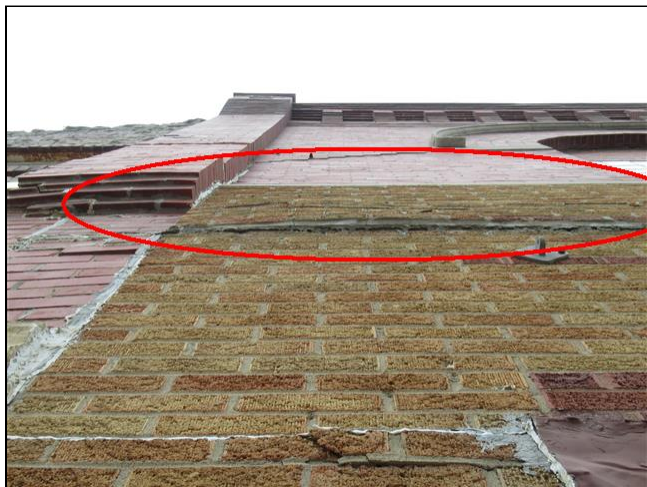
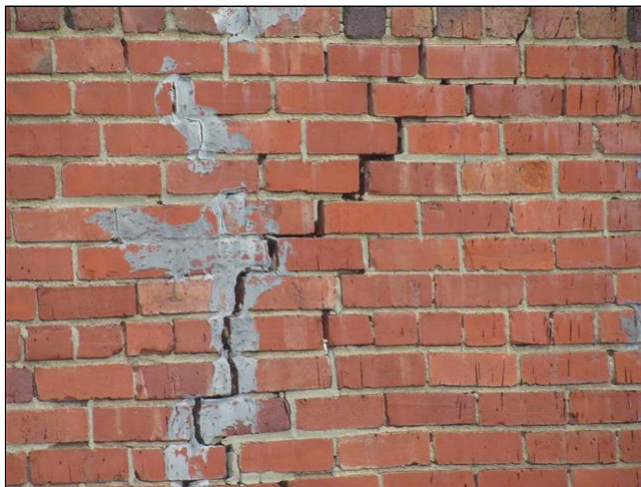
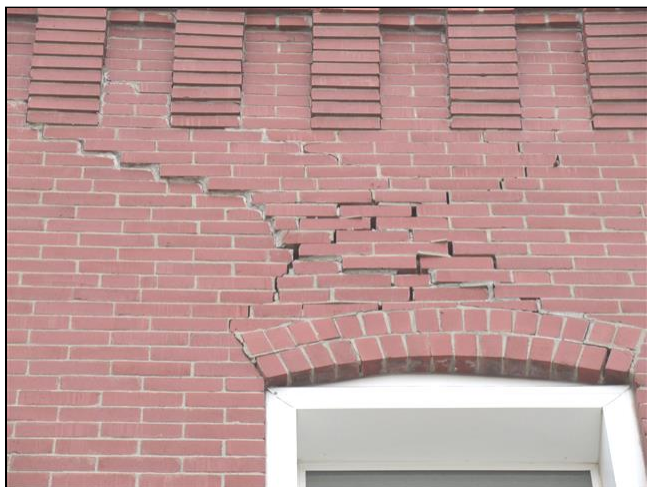
- Exterior wall deficiencies:
  1. Severe brickwork settlement (Picture 1-3).
  2. Loose/missing bricks (Picture 4).
  3. Severe brickwork fretting; visible from exterior & attic (Picture 5-6).
  4. Cracked stonework (Picture 7).
  5. Wood rot damage (Picture 8-10).
  6. Unsealed wall penetrations.

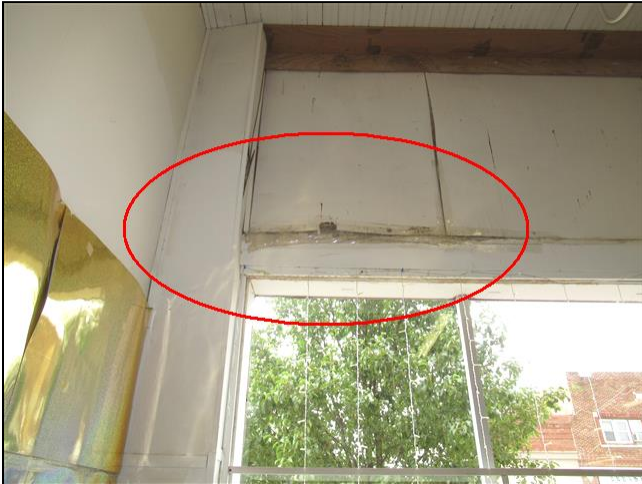
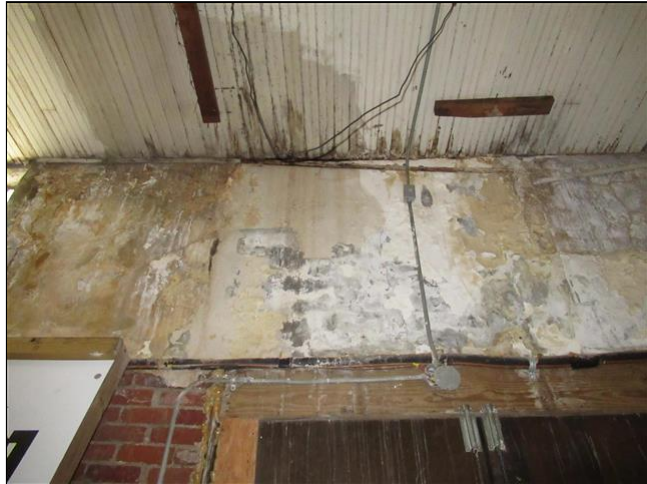
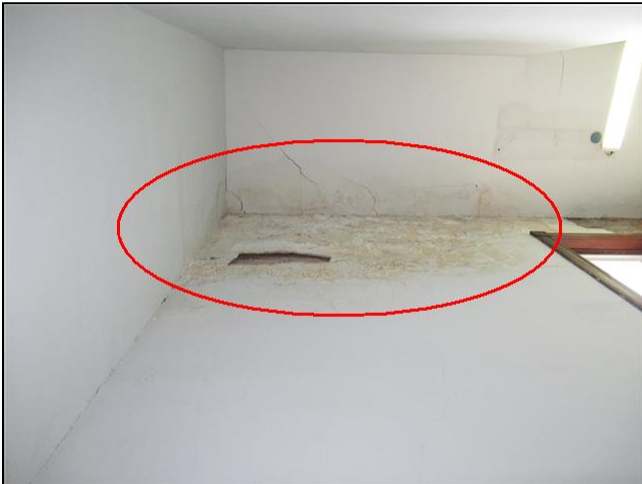
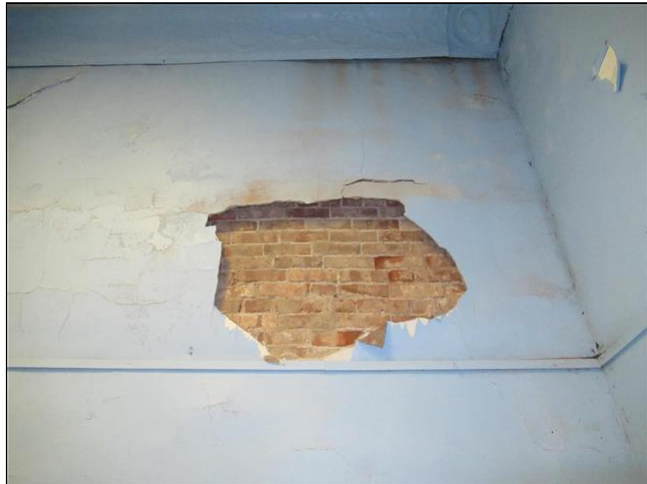
- Interior wall deficiency; water damage is visible at multiple locations throughout the building (Picture 11-14).

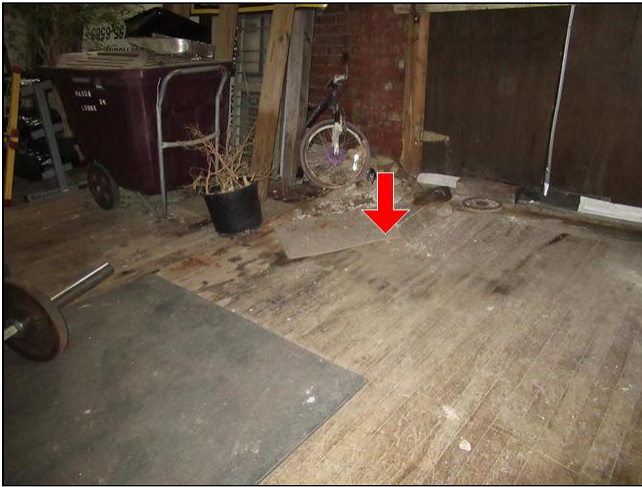
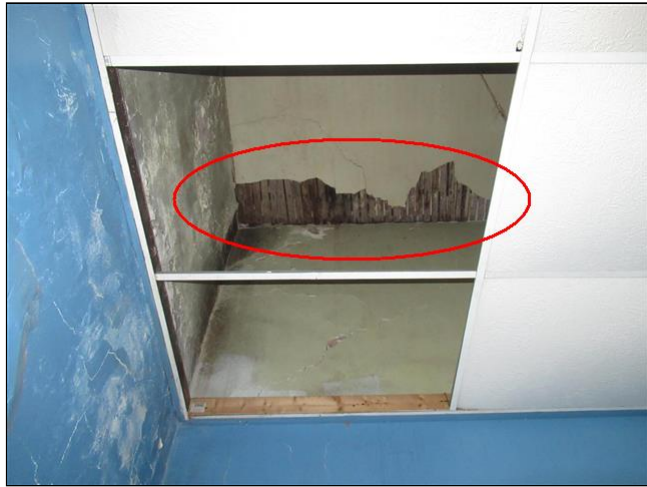
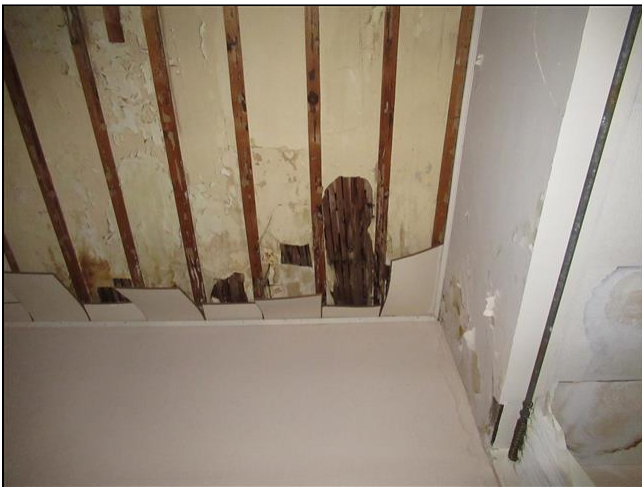
- Ceiling & Floor Structure deficiencies:
  1. Water damage is visible at multiple locations throughout the building (Picture 1-3).
  2. Visible from crawlspace; severe termite and water damage:
    - A) Floor joists (Picture 4).
    - B) Wooden support posts (Picture 5).
  3. Rust damaged steel columns (Picture 6).
  4. Vertical pier settlement; north piers +1".
  5. Inadequate crawlspace ventilation.
  6. Crawlspace is not equipped with a vapor barrier system.

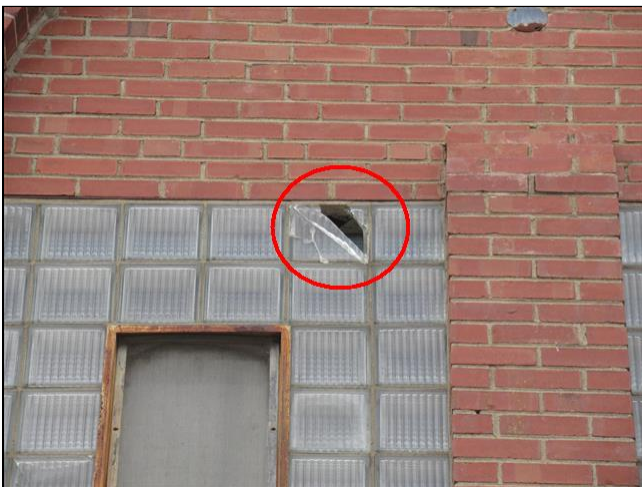
K. (Picture 1)

1. First & second levels, multiple locations; glass blocks are broken (Picture 1).
2. Evidence of water intrusion is visible at first level windows; interior water damage (Picture 2).

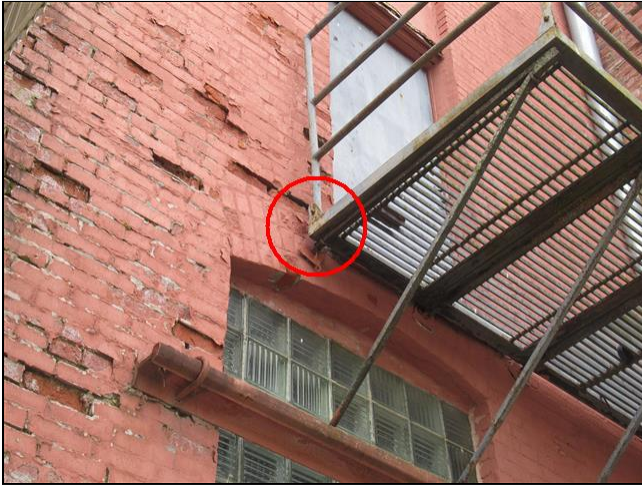
L. (Picture 1)

- Exterior stair deficiencies:
  1. Lateral settlement/separation (Picture 1).
  2. Rust damaged columns (Picture 2).
  3. Incomplete/damaged/undersized stair treads (Picture 3).
  4. Risers are not installed.
  5. Railing system is inadequate/incomplete.
  6. Inadequately supported.

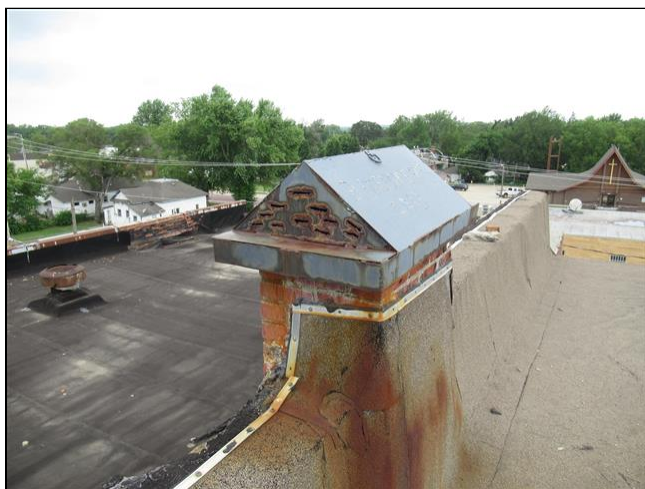
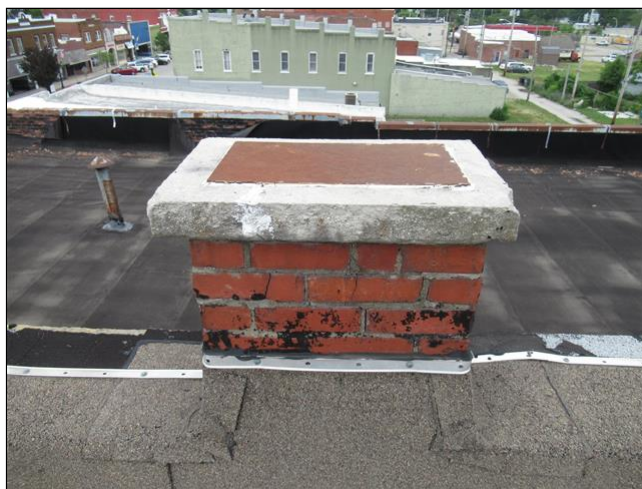
- Utility chimneys:
  1. Were not evaluated (NI).
  2. Interior of chimneys are not visible due to caps (Picture 1-2).

3. Presumably unlined.

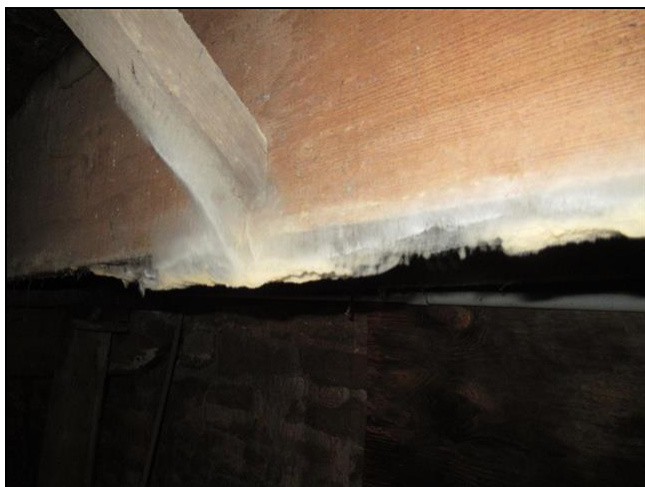
Q. (Picture 1)

1. Heavy mold growth is visible at multiple locations throughout the accessed portions of the crawlspace (Picture 1).
2. Mold is visible at multiple locations throughout the building.

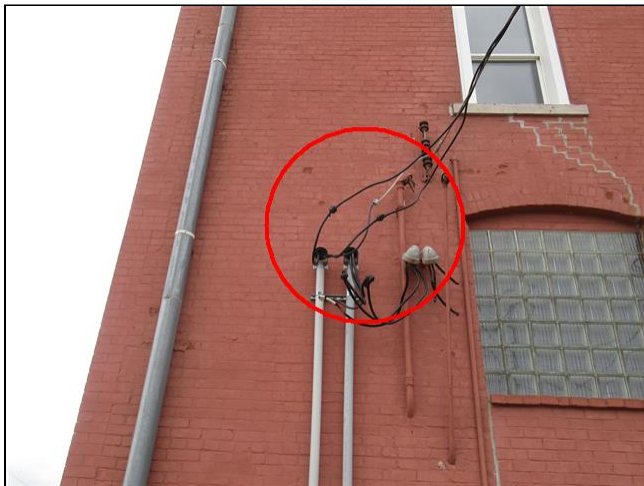
A. (Picture 1)

1. Exterior; inadequate drip loop (Picture 1).
2. Multiple panels:
  - A) Inadequate grounding.
  - B) Incomplete labeling.

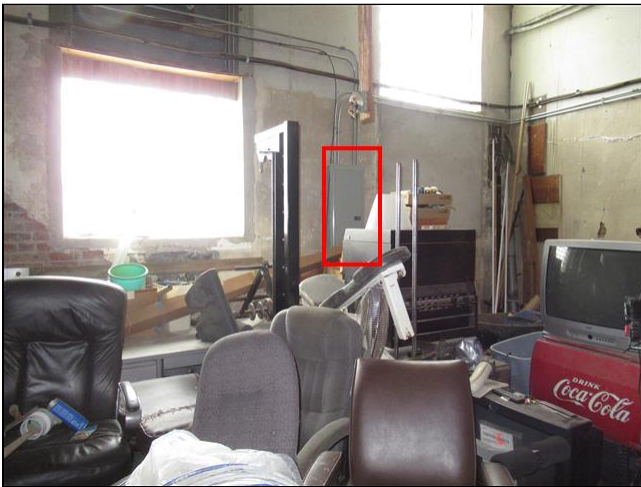
A. (Picture 2)

- First level:
  1. North panel was not accessible to inspect due to stored items (Picture 2).
  2. Dead front covers are not installed (Picture 3).
  3. Cable tray cover is not installed (Picture 4).
  4. Open terminals & wires (Picture 5).
  5. Double tapped lugs (Picture 6).
  6. Evidence of overheating; melted wire insulation (Picture 7).
  7. Undersized supply wiring.

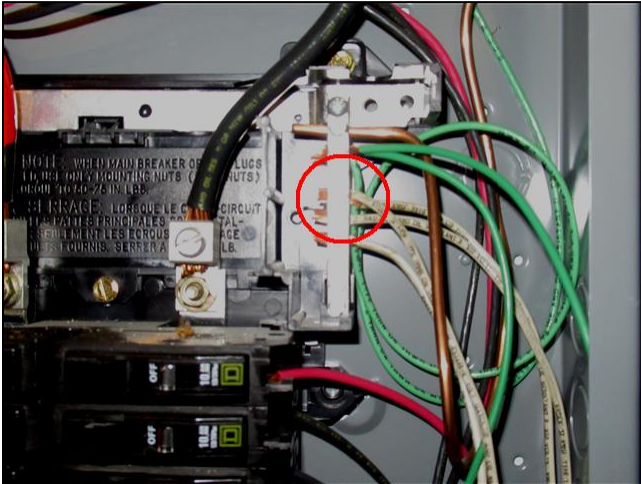
A. (Picture 8)

- Second level:
  1. Double tapped neutral connection (Picture 8).
  2. Obsolete fuse box (Picture 9).
  3. Double tapped circuit breaker (Picture 10).

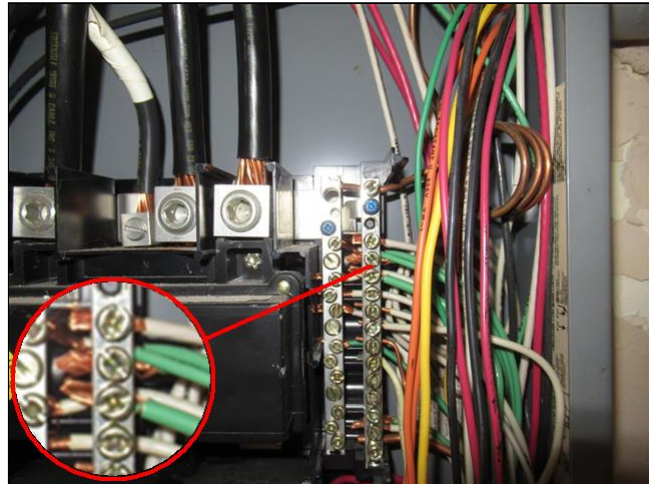
A. (Picture 11)

4. Double tapped neutral/ground connections (Picture 11).
5. Missing bonding screw x1.

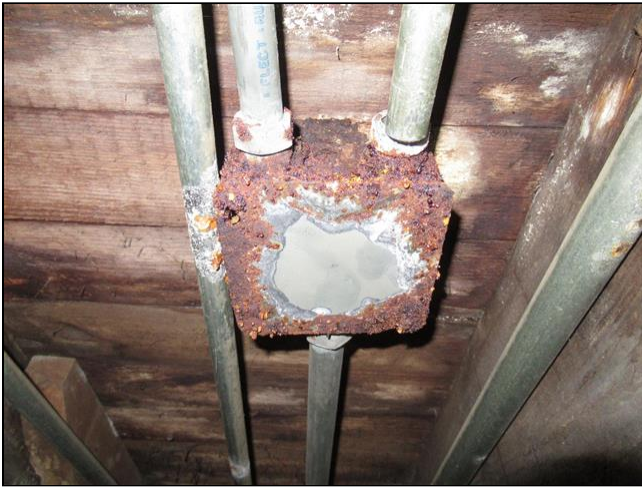
B. (Picture 1)

- Crawlspace:
  1. Water damaged wiring (Picture 1).
  2. Open/exposed wiring.

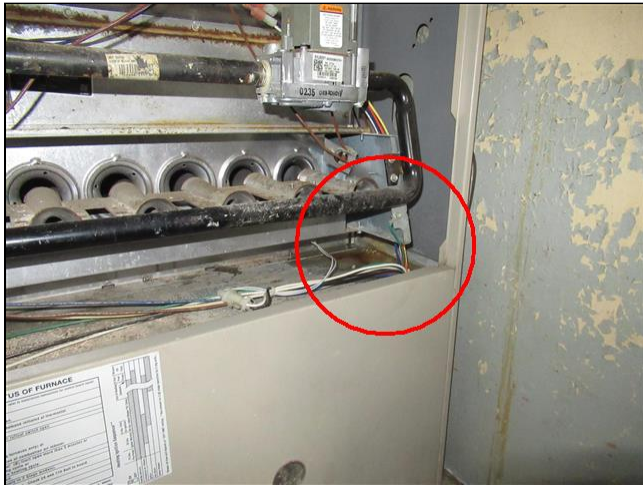
B. (Picture 1)

- B.**
1. First level:
    - A) West system; condensation is leaking into the furnace cabinet (Picture 1).
    - B) Noted; limited life expectancy of equipment (2002).
  2. The second level of the building is not equipped with a cooling system (NP).

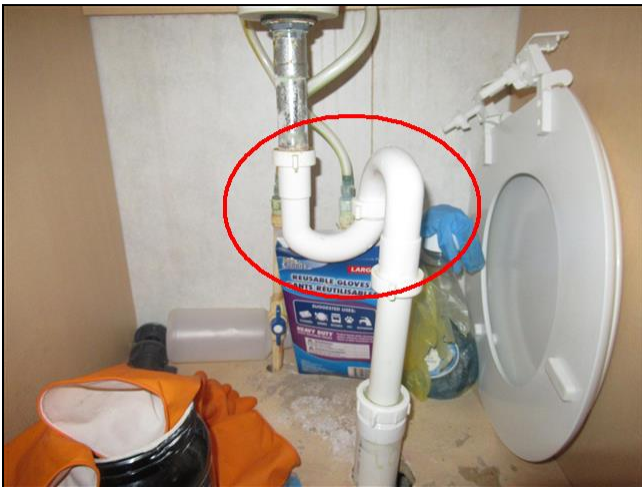
B. (Picture 1)

- B.**
1. All three bathrooms; sink drains are not vented (Picture 1).
  2. Kitchen sink drain; improper installation (Picture 2).
  3. Crawlspace:
    - A) Undesignated/open piping (Picture 3-4).
    - B) Improper connection; PVC/Cast transition (Picture 5).
    - C) Inadequate repairs; duct tape (Picture 6).

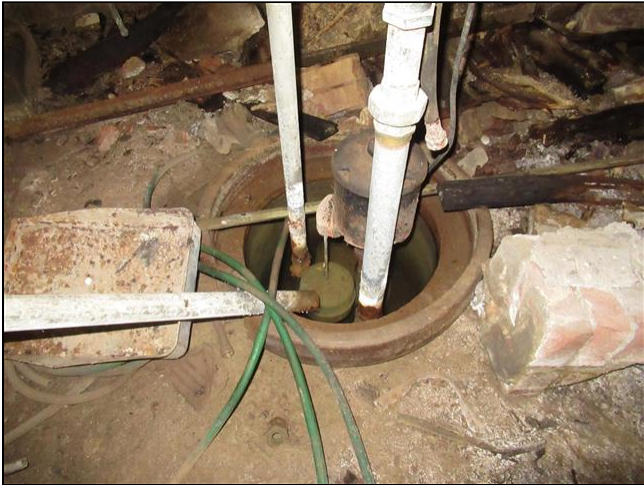
E. (Picture 1)

- Sump pump system is not operable (Picture 1).
