Inspection Report

Property Address:
4000 SE Hill Street
Kansas City MO 64112

Gordon & Associates

Date: 7/4/2023	Time:	Report ID: 223777S
Property: 4000 SE Hill Street Kansas City MO 64112	Customer: Joseph Mazza	Real Estate Professional: Daniel Demers

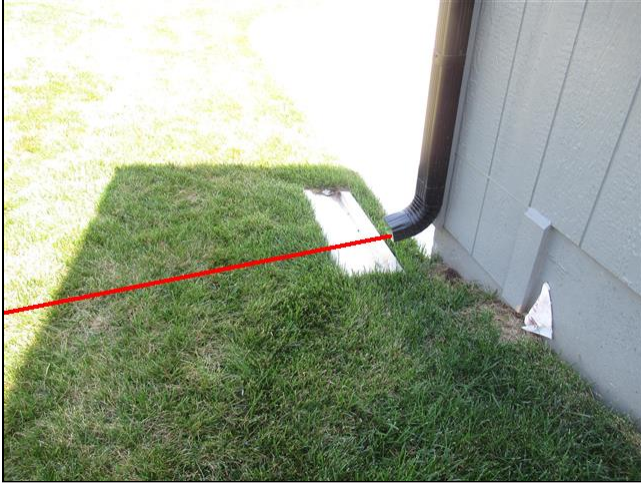
B. (Picture 1)

1. Downspouts are not extended to discharge a minimum of 6 feet from the foundation walls (Picture 1).
2. Poor soil grading (Picture 2-3). Final grading around the entire foundation should provide a minimum of 6" of slope in the first 6' directly away from the foundation while maintaining 6" of clearance below the siding. The grade should provide for an easy flow of surface water away from the foundation and off the property.

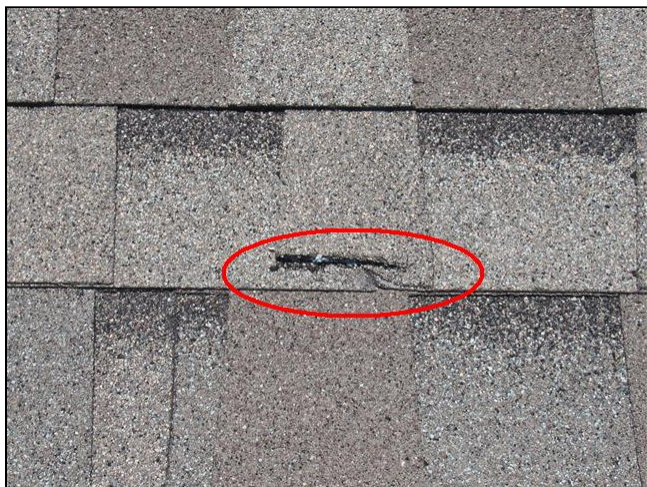
C. (Picture 1)

- **Roof covering deficiencies:**
 1. Damaged shingle (Picture 1) x1.
 2. Multiple lifted shingles (Picture 2).
 3. Unsealed flashing connections (Picture 3).

1. Damaged shingle (Picture 1) x1.
2. Multiple lifted shingles (Picture 2).
3. Unsealed flashing connections (Picture 3).

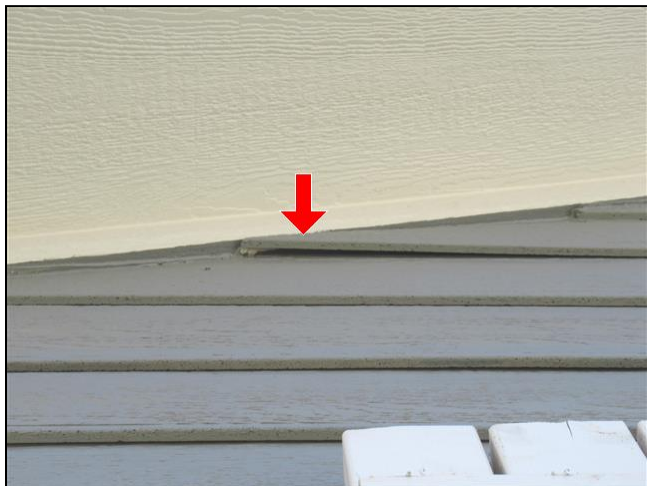
E. (Picture 1)

- **Exterior/wall deficiencies:**
 1. Loose siding connections; east wall (Picture 1).
 2. Incomplete paint coverage; multiple locations (Picture 2-5).
 3. Peeling paint; overhead garage doors (Picture 6).
 4. Incomplete caulking/sealing (Picture 7).
 5. Caulking failure (Picture 8).

1. Loose siding connections; east wall (Picture 1).
2. Incomplete paint coverage; multiple locations (Picture 2-5).
3. Peeling paint; overhead garage doors (Picture 6).
4. Incomplete caulking/sealing (Picture 7).
5. Caulking failure (Picture 8).

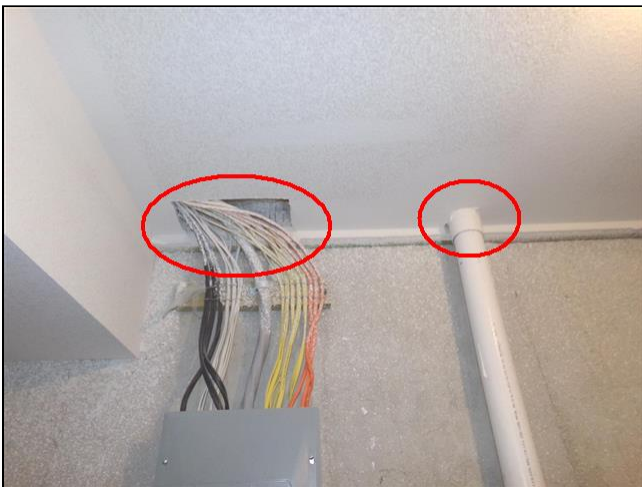
H. (Picture 1)

- H.
- **Ceiling deficiency;** incomplete fire separation between garage & living space (Picture 1).

- **Ceiling deficiency;** incomplete fire separation between garage & living space (Picture 1).

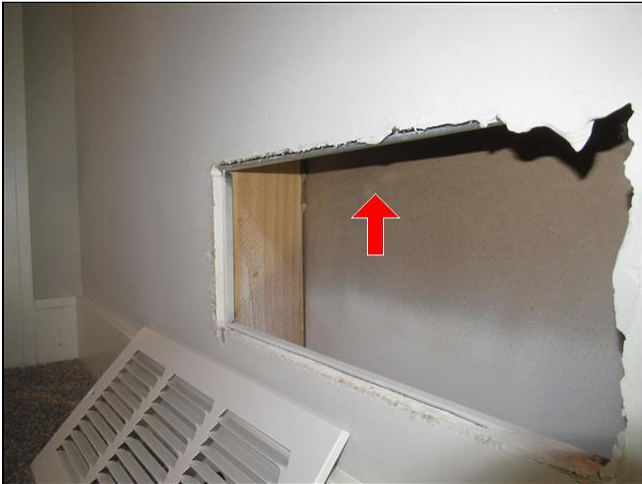
Q. (Picture 1)

- **Mold inspection photos:**
 - 1. Mold is visible throughout the basement level of the home; inside finished walls (Picture 1-2).
 - 2. Noted:
 - A) Basement drywall removal & replacement will be required for mold remediation.
 - B) See supplemental Microbial Lab report for additional information.

- **Mold inspection photos:**
 1. Mold is visible throughout the basement level of the home; inside finished walls (Picture 1-2).
 2. Noted:
 - A) Basement drywall removal & replacement will be required for mold remediation.
 - B) See supplemental Microbial Lab report for additional information.

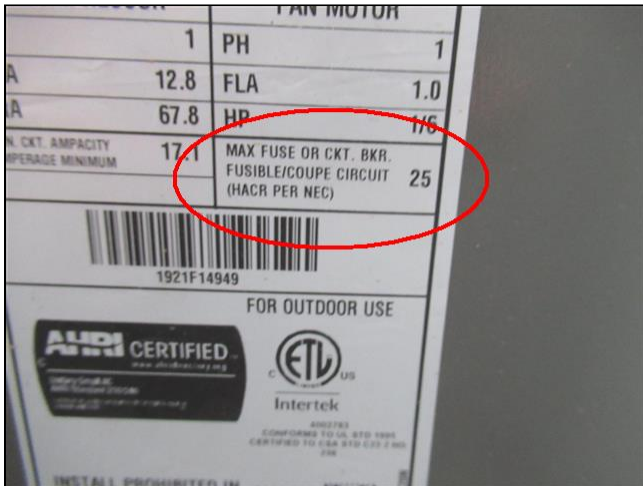
A. (Picture 1)

- A.**
- **Panel deficiency;** AC unit circuit breakers are oversized, (Picture 1) 25 Amps max, (Picture 2) 30s are currently installed.

- **Panel deficiency;** AC unit circuit breakers are oversized, (Picture 1) 25 Amps max, (Picture 2) 30s are currently installed.

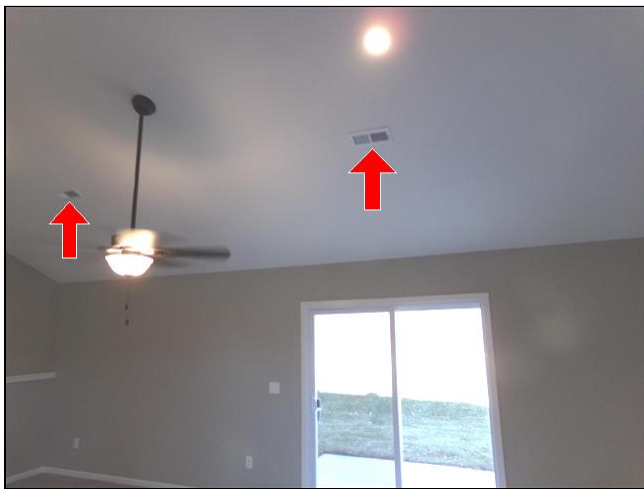
A. (Picture 1)

1. No air flow; living room supply registers (Picture 1).
2. Disconnected ductwork; attic (Picture 2).

- **Heating system deficiencies:**
 1. No air flow; living room supply registers (Picture 1).
 2. Disconnected ductwork; attic (Picture 2).

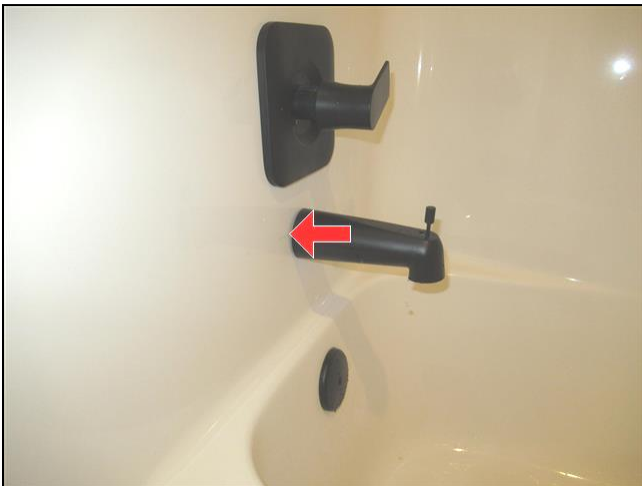
A. (Picture 1)

1. Basement level bathroom; loose tub spout wall anchor (Picture 1).
2. Main level hall bathroom tub faucet; hot & cold are reversed (Picture 2).

- **Water supply system & fixture deficiencies:**
 1. Basement level bathroom; loose tub spout wall anchor (Picture 1).
 2. Main level hall bathroom tub faucet; hot & cold are reversed (Picture 2).

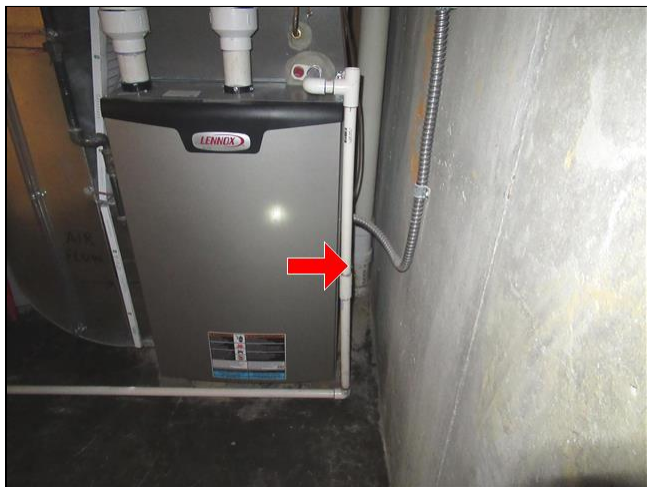
B. (Picture 1)

- **Plumbing drain, waste & vent deficiencies:**
 1. Main clean-out is not accessible; located behind furnace (Picture 1).
 2. Tape has not been removed from floor drains (Picture 2).

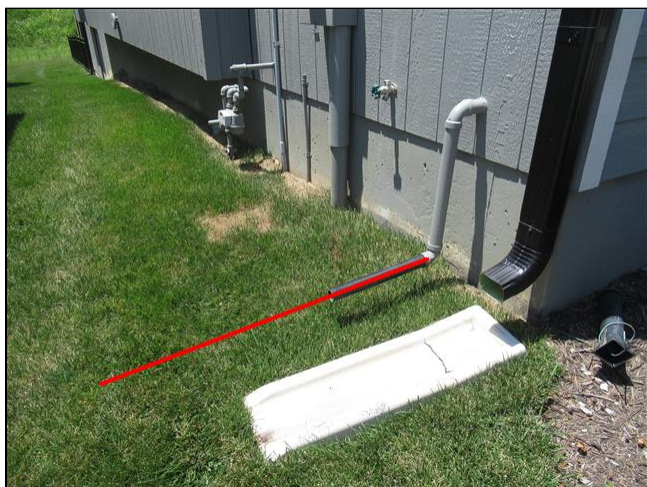
E. (Picture 1)

- **Sump pump deficiencies:**
 1. Missing drain pipe (Picture 1).
 2. Basin is not equipped with battery backup and high water level alarm systems.

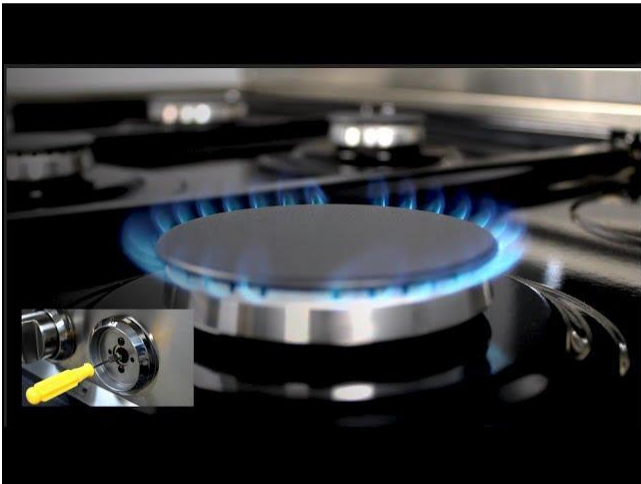
D. (Picture 1)

- **Gas cooktop deficiency;** low burner heights; multiple burners flame out when turned to low settings (Picture 1).

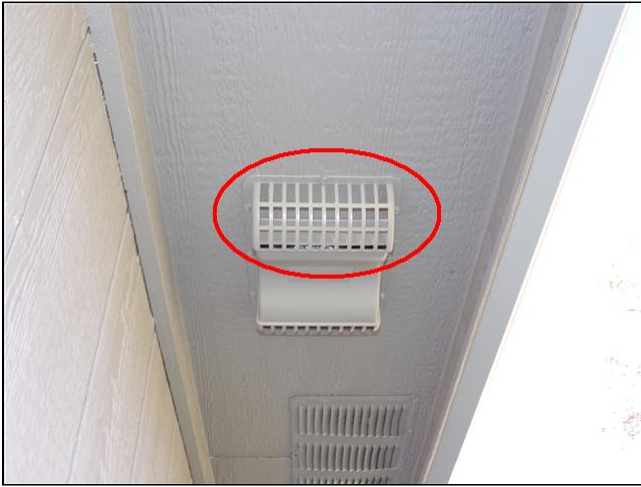
G. (Picture 1)

- **Bathroom exhaust fan deficiency**; all bathrooms; no airflow at exterior points of discharge with fans operating (Picture 1).

- **Bathroom exhaust fan deficiency;** all bathrooms; no airflow at exterior points of discharge with fans operating (Picture 1).
