# Inspection Report

**Property Address:**  
1501 W 5th Avenue  
Kansas City MO 64129

**Gordon & Associates**

<b>Date:</b> 11/29/2023	<b>Time:</b>	<b>Report ID:</b> 223777
<b>Property:</b> 1501 W 5th Avenue Kansas City MO 64129	<b>Customer:</b> Mike Holmes	<b>Real Estate Professional:</b> Ben Caballero

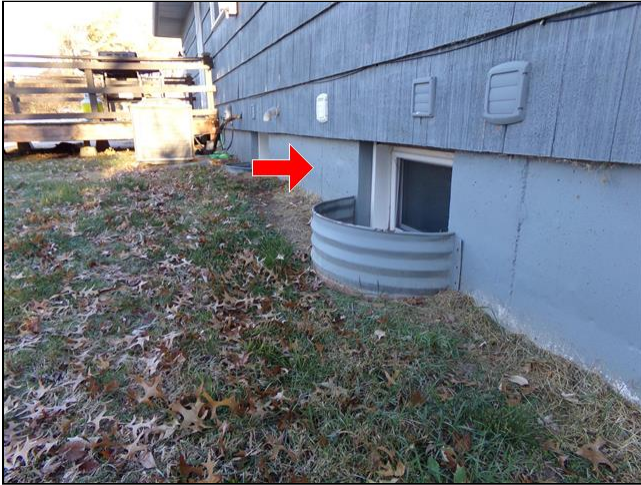
A. (Picture 1)

1. Lateral settlement at south & east walls (Picture 1).
  - A) South wall measurement 1.375" inward.
  - B) East wall measurement 0.875" inward.
2. Hinge cracks (Picture 2).

- **Foundation deficiencies:**
  1. Lateral settlement at south & east walls (Picture 1).
    - A) South wall measurement 1.375" inward.
    - B) East wall measurement 0.875" inward.
  2. Hinge cracks (Picture 2).

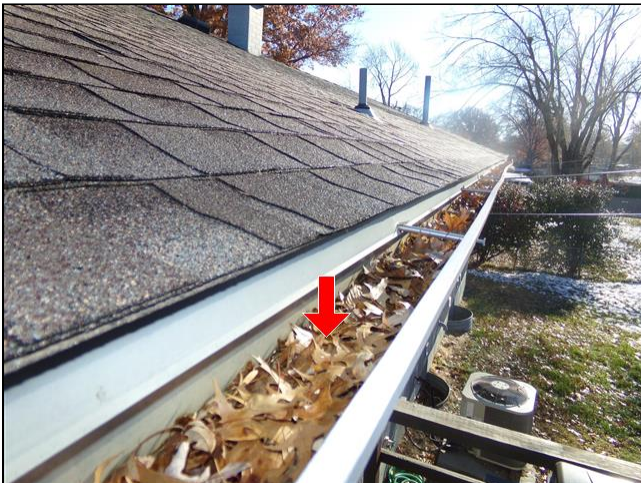
B. (Picture 1)

1. Obstructed guttering (Picture 1).
2. Downspouts are not extended to discharge a minimum of 6 feet from the foundation walls (Picture 2).
3. Loose guttering spikes (Picture 3).
4. Back pitched patio; diverting watershed towards foundation (Picture 4).
5. Poor soil grading. Final grading around the entire foundation should provide a minimum of 6" of slope in the first 6' directly away from the foundation while maintaining 6" of clearance below the siding. The grade should provide for an easy flow of surface water away from the foundation and off the property.

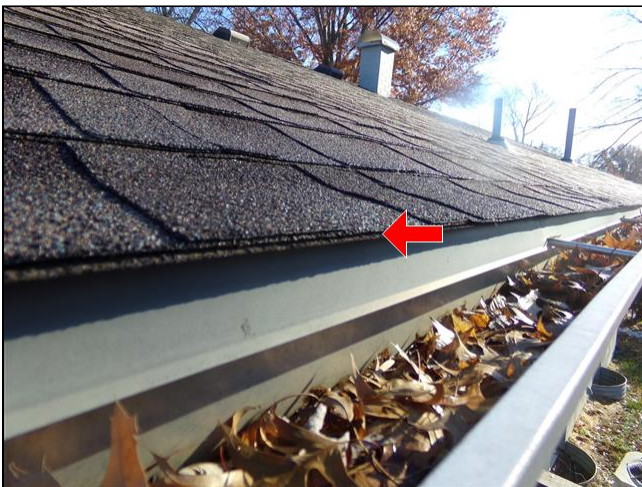
C. (Picture 1)

- **Roof covering deficiencies:**
  1. The underlayment does not overlap the drip edge flashing (Picture 1).
  2. Lifted shingles (Picture 2).
  3. Unsecured flashings (Picture 3).

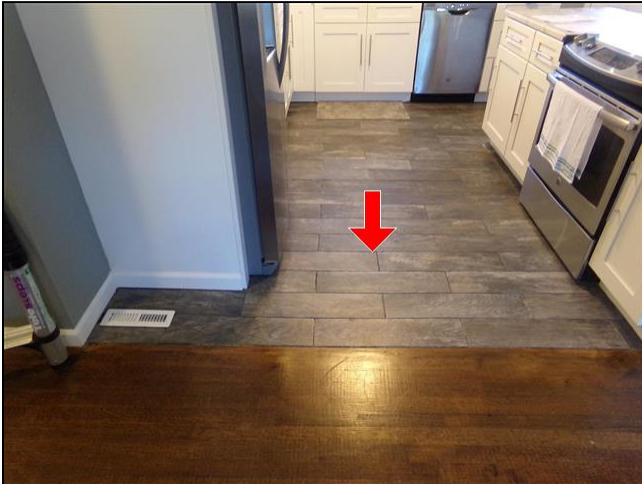
E. (Picture 1)

1. **Noted;** loose kitchen floor tile/grout (Picture 1).
2. **Floor structure deficiency;** termite damage; see section S. below.

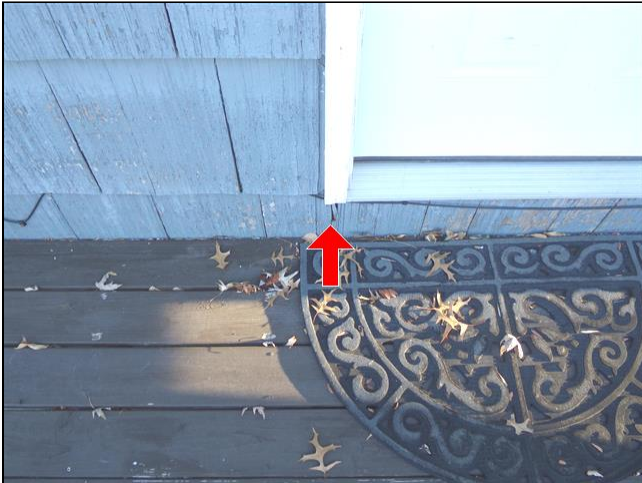
F. (Picture 1)

- **Exterior/wall deficiencies:**
  1. Wood rot damage (Picture 1).
  2. Split/damaged siding (Picture 2).
  3. Loose siding (Picture 3-5).
  4. Large hole in wall (Picture 6).
  5. Missing flashing (Picture 7).
  6. Peeling paint + incomplete caulking/sealing (Picture 8-10).

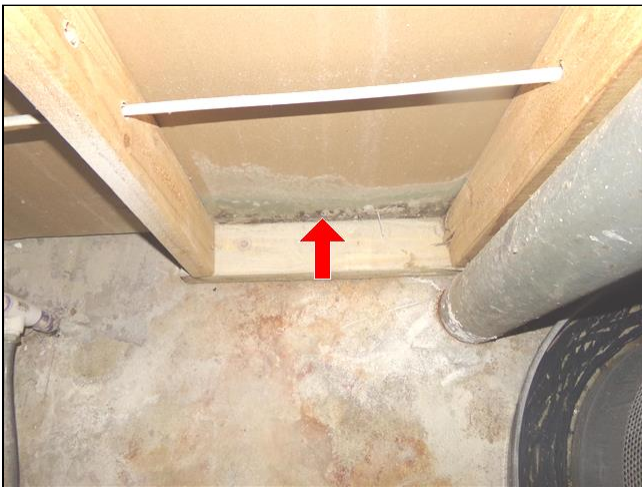
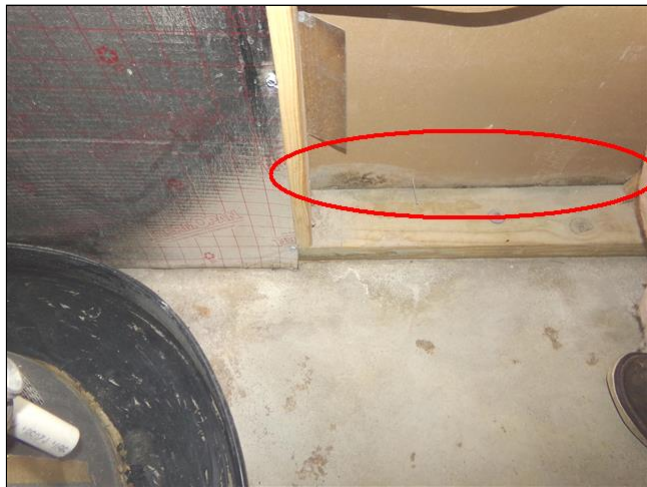
- 1. **Visible mold;** basement utility room (Picture 1-2).
- 2. **Noted;** cause & extent of damage to basement unknown.

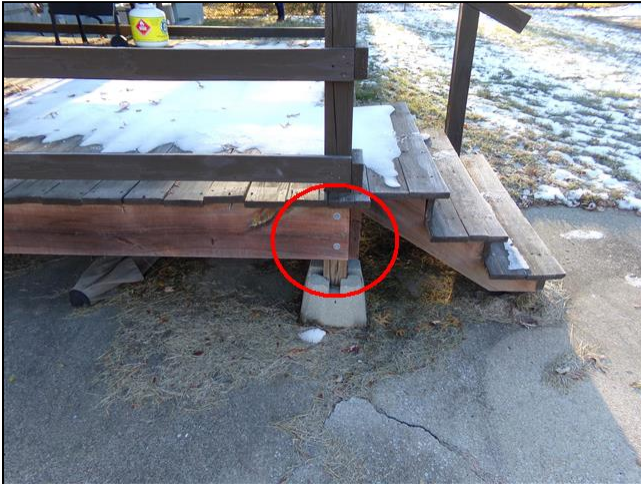
H. (Picture 1)

- **Deck deficiencies:**
  1. Main beams are not bearing directly onto the support posts (Picture 1).
  2. Inadequate/incomplete railing system (Picture 2).
  3. Loose/disconnected lumber (Picture 3-4).
  4. Wood rot damage (Picture 5).
  5. Joist sag (Picture 6).

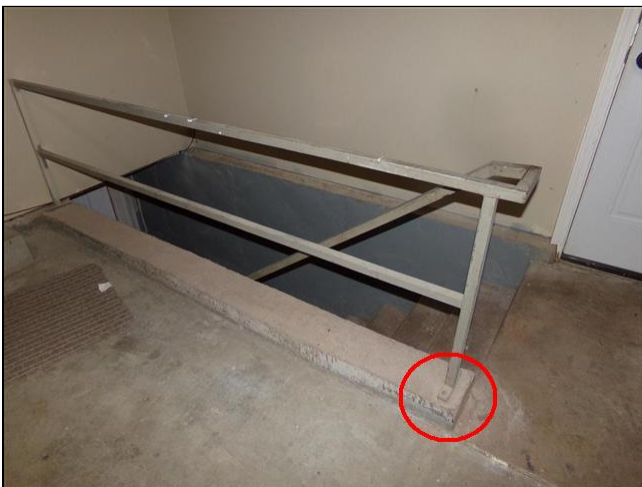
L. (Picture 1)

1. Outdated railing system + loose; basement stairwell (Picture 1).
2. Incorrect riser height; garage step height greatly exceeds 7.75" (Picture 2).

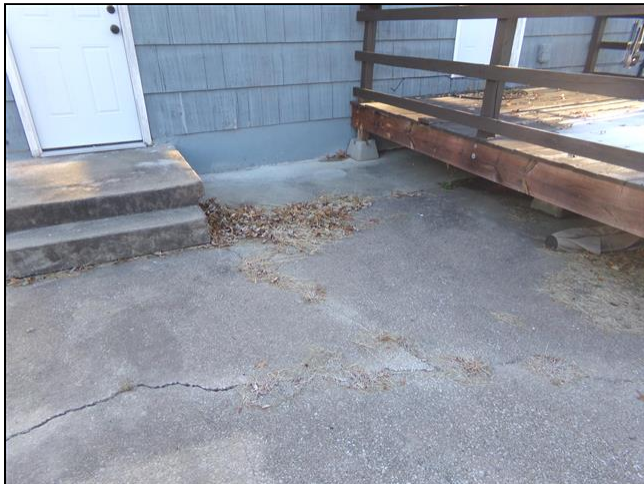
Q. (Picture 1)

- **Patio deficiencies;** cracks, settlement (Picture 1).

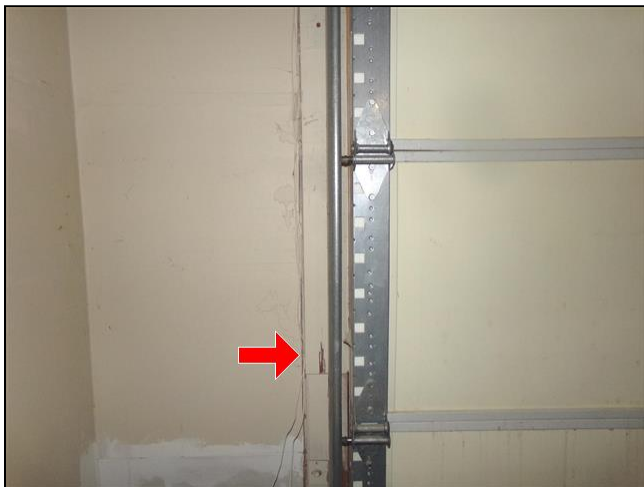
S. (Picture 1)

1. **Visible termite damage:**
  - A) North garage wall (Picture 1).
  - B) Floor joists beneath front entry (Picture 2-3).
2. **Noted;** drywall removal will be necessary to determine the extent of damage.

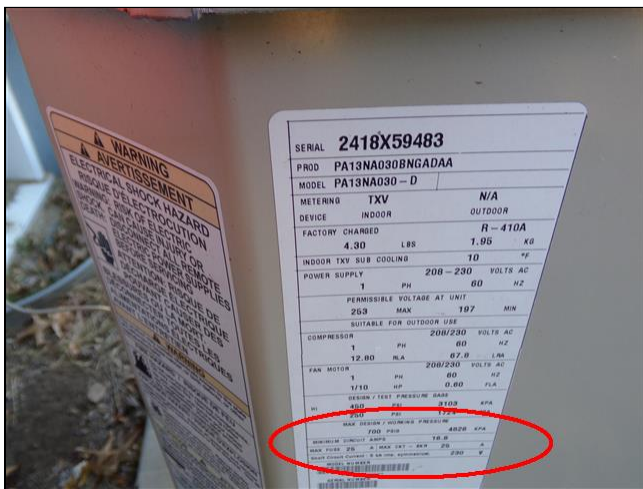
A. (Picture 1)

- A.**
- **Service entrance and panel deficiencies:**
    1. Incorrect circuit breaker and wire sizing; AC unit (Picture 1) + branch circuits (Picture 2-3).
    2. Current demand (240v circuits x5) exceeds 100 Amp service size.

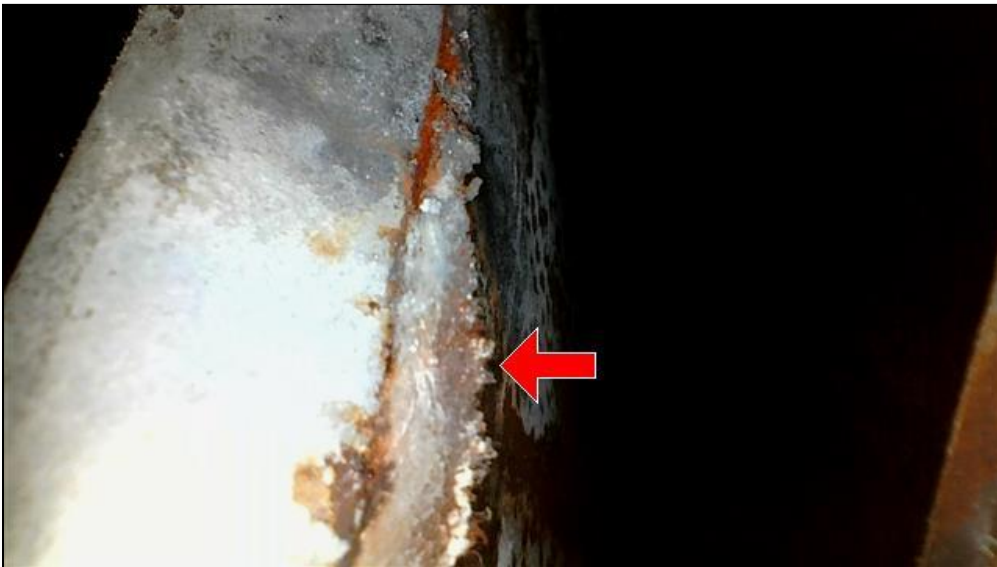
A. (Picture 1)

- A) Cracked heat exchanger; borescope photo from inside heat exchanger (Picture 1).
- B) Inoperable humidifier system.

**2. Noted;** not repairable, requires replacement.

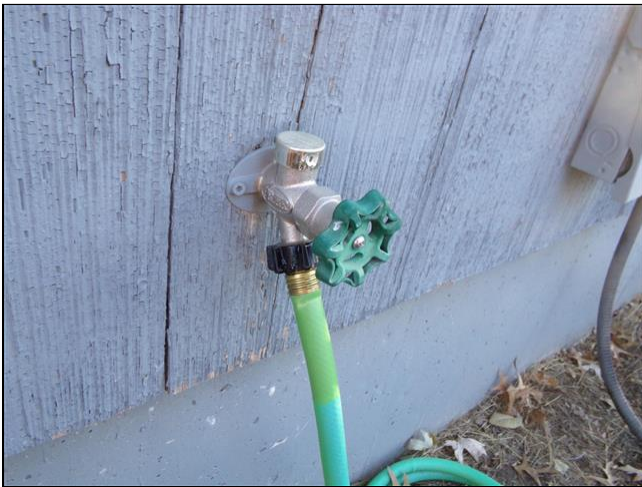
A. (Picture 1)

- **Plumbing supply & fixture deficiencies:**
  1. Hose connected to water spigot during winter weather (Picture 1).
  2. Loose water spigot (Picture 2).
  3. Defective kitchen sink faucet prayer (Picture 3).
  4. Defective toilet flush valve; main level bathroom (Picture 4).
  5. Loose wall anchor; main level bathroom tub spout pipe (Picture 5).
  6. Defective tub spout diverter; basement bathroom (Picture 6).
  7. Loose tub faucet handle; basement bathroom (Picture 7).

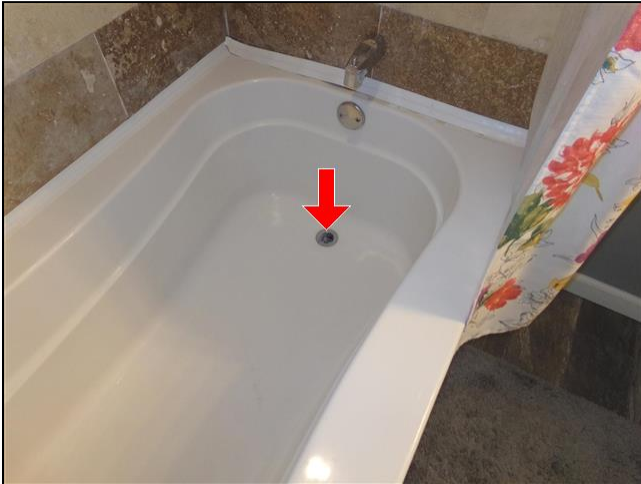
B. (Picture 1)

1. Missing drain stopper; main level bathroom bathtub (Picture 1).
2. Missing drain stopper + linkage + lever; basement bathroom (Picture 2).
3. Missing vent; basement bathroom sink drain (Picture 3).
4. Basement floor drain is obstructed and the clean out plug has been removed (Picture 4).

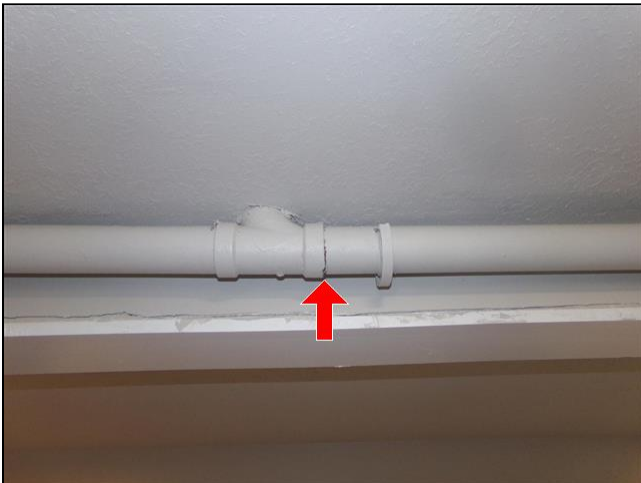
B. (Picture 5)

- 5. Leaking drain connection; basement kitchen ceiling (Picture 5).
- 6. Utility room is not equipped with a serviceable floor drain system (Picture 6).

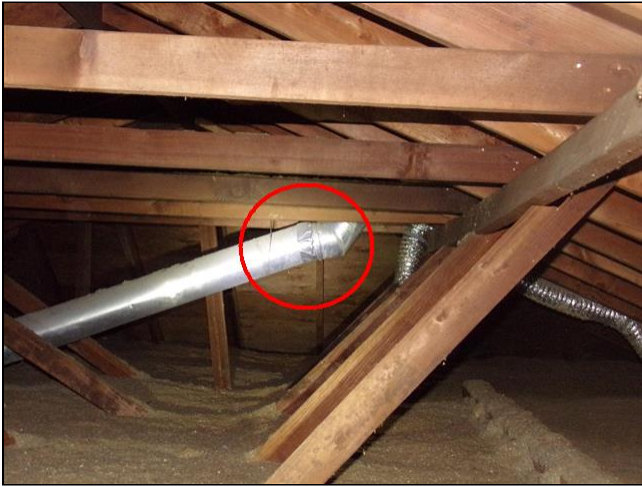
C. (Picture 1)

- C.
- **Water heater deficiencies:**
    - 1. Duct taped flue pipe connection; attic (Picture 1).
    - 2. Melted plastic near flue hood is an indication of back drafting (Picture 2).

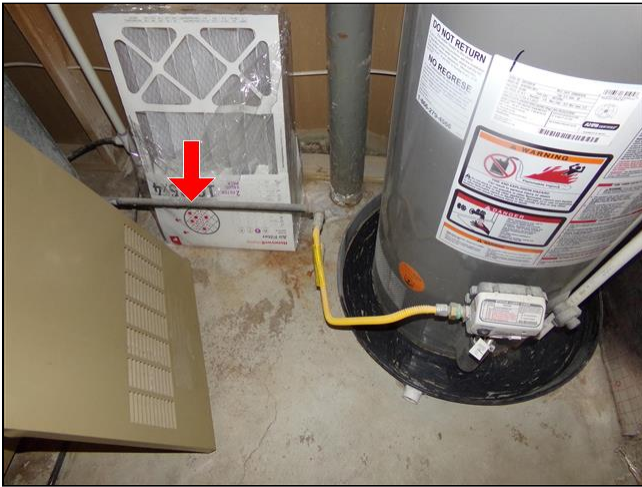
C. (Picture 3)

- 3. Gas supply is not supported + missing drip leg (Picture 3).
- 4. Missing flue pipe screws (Picture 4).
- 5. Inadequate flue pipe cap (Picture 5).

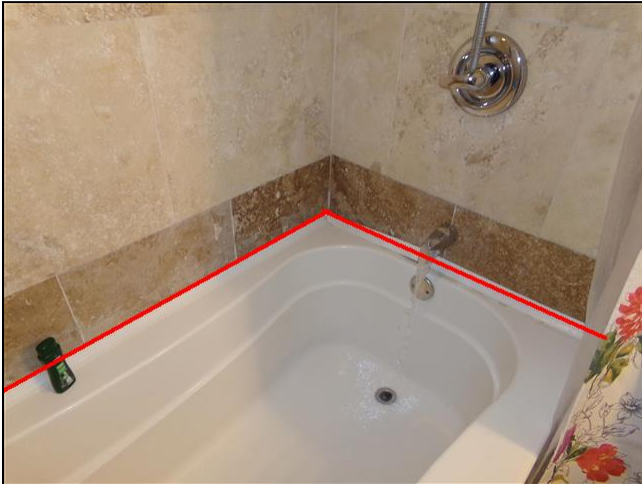
E. (Picture 1)

- Shower wall deficiency; inadequate caulking/sealing (Picture 1).

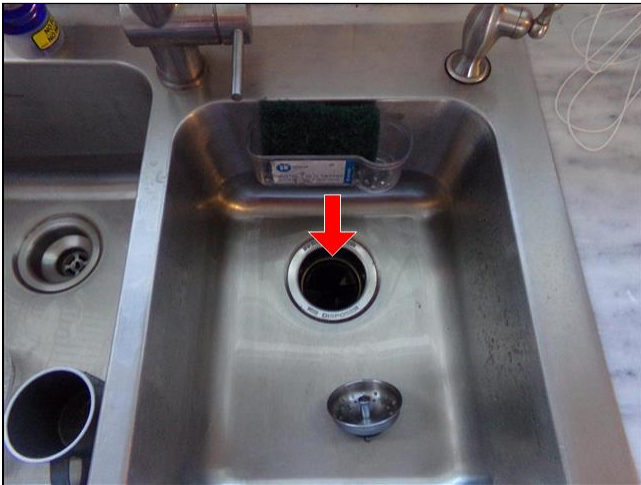
B. (Picture 1)

1. Damaged disposal splash guard (Picture 1).
2. Limited life expectancy of disposal.

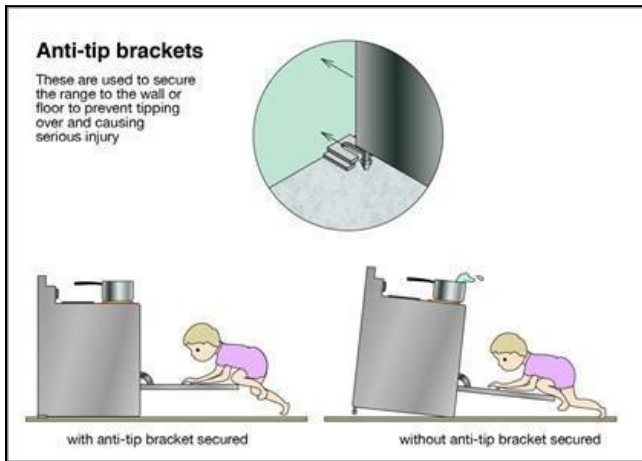
D. (Picture 1)

- Slide in oven/range deficiency; missing anti-tip bracket (Picture 1).
